# Access Compliance Report

## Public Rights-of-Way

### (Curb Ramps)

Intersection ID: 14441	Main Street: E_KINGSTON_AV	Cross Street: SPRINGDALE_AV	Location: E
ADA ID: F2C7FDA24773	Ramp Type: Perp	Initial Pass/Fail: Fail	Overall Compliance: No
Severity Score: 12.5			
Codes/Mitigation Info/Possible Solution		Field Measurements/Component Compliance

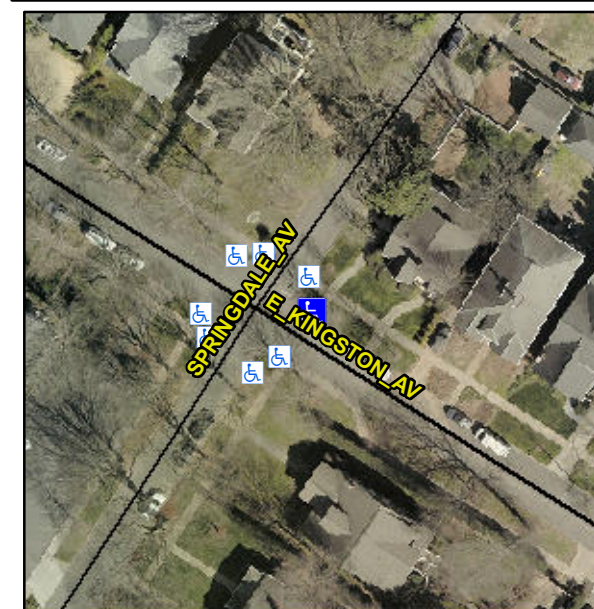
Compliance	Description	Data	Compliance	Description	Data
N/A	Ramp Length (in)	24.0	No	Ramp Slope (%)	9.5
Yes	Ramp Width (in)	53.0	Yes	Ramp XSlope (%)	0.5
N/A	Flare Type LT	N/A	N/A	Flare Type RT	N/A
N/A	Flare Slope LT (%)	N/A	N/A	Flare Slope RT (%)	N/A
N/A	Flare Traversable LT?	N/A	N/A	Flare Traversable RT?	N/A
N/A	Landing Length (in)	N/A	N/A	DWS Provided?	N/A
N/A	Landing Width (in)	N/A	N/A	DWS Contrast?	N/A
N/A	Landing Slope (%)	N/A	N/A	DWS Length (in)	N/A
N/A	Landing X Slope (%)	N/A	N/A	DWS Full Width?	N/A
N/A	Landing Curb? (Y/N)	N/A	N/A	DWS Offset (in)	N/A
N/A	Shared Landing?	N/A			
N/A	Gutter Ponding?	N/A	N/A	Gutter Slope (%)	N/A
N/A	Gutter Lip Ht (in)	N/A	N/A	Gutter X Slope (%)	N/A
N/A	Painted X Walk1?	No	N/A	Painted X Walk2?	N/A
	X Walk 1 Direction	To SW		X Walk 2 Direction	N/A
N/A	X Walk 1 Width (in)	N/A	N/A	X Walk 2 Width (in)	N/A
	X Walk 1 Slope (%)	4.9		X Walk 2 Slope (%)	N/A
	X Walk 1 X Slope (%)	0.5		X Walk 2 X Slope (%)	N/A

N/A	Ramp inside XWalk1?	N/A	N/A	Ramp inside XWalk2?	N/A
	Road Slope (%)	N/A	N/A	Clear Space?	N/A
	Road X Slope (%)	N/A	N/A	Clear Space to XWalk (in)	N/A
N/A	Any Obstructions?	N/A	N/A	Storm Grate/Utility Hazard?	N/A
	Obstruction Type			Storm Grate/Utility Type	
		N/A			N/A
			Yes	Surface Condition? (G/P)	Good

Possible Solutions:

**Remove & Replace Entire Ramp.**

**R304.2.2**

**\$ 1850.00**
