Access Compliance Report

Public Rights-of-Way

(Curb Ramps)

| Intersection ID: 54217 | Main Street: GOLF_LINKS_DR | Cross Street: MIDWAY_PARK_DR | Location: NE |

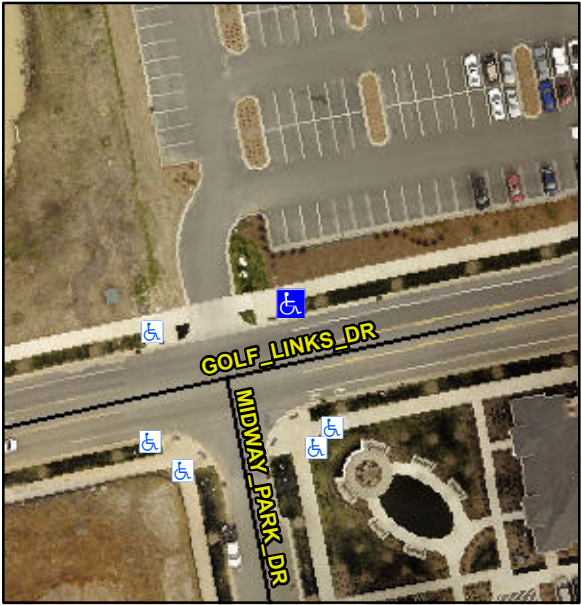
| ADA ID: F2C84C3F6537 | Ramp Type: Perp | Initial Pass/Fail: Fail | Overall Compliance: No |
| | | | Severity Score: 13.75 |

| Codes/Mitigation Info/Possible Solution | | Field Measurements/Component Compliance | | | | | |
|--|---|---|---|---|---|---|---|
| | Remove & Replace Entire Ramp. | N/A | Ramp Length (in) | 94.0 | No | Ramp Slope (%) | 9.8 |
| | | Yes | Ramp Width (in) | 61.0 | No | Ramp XSlope (%) | 2.5 |
| <p>Surveyor Notes:</p> <p>N/A</p> <p>PROW/ADA:</p> <p>R304.2.2, R304.5.3</p> | | N/A | Landing Curb? (Y/N) | N/A | N/A | DWS Offset (in) | N/A |

| Codes/Mitigation Info/Possible Solution | | Field Measurements/Component Compliance | | | | | |
|--|---|---|---|---|---|---|---|
| | Possible Solutions: | | | | | | |
| <p>Total Cost:</p> <p>\$ 1850.00</p> | | | Road Slope (%) | N/A | N/A | Clear Space? | N/A |
