Access Compliance Report

Public Rights-of-Way

(Curb Ramps)

Intersection ID: 20587	Main Street: COLONY_RD	Cross Street: FAIRVIEW_RD	Location: SE
ADA ID: F2CBC199A59A	Ramp Type: Perp	Initial Pass/Fail: Fail	Overall Compliance: No
Severity Score: 12.5			
Codes/Mitigation Info/Possible Solution		Field Measurements/Component Compliance

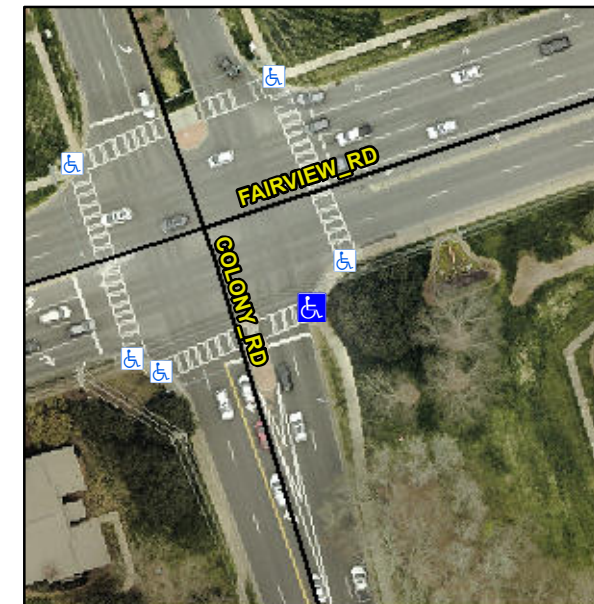
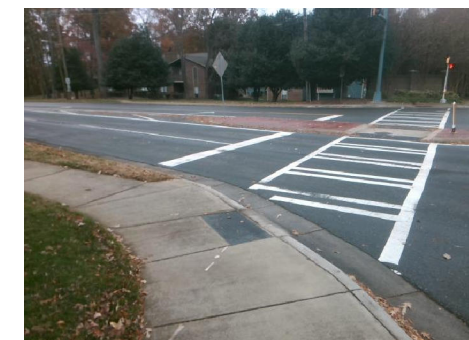
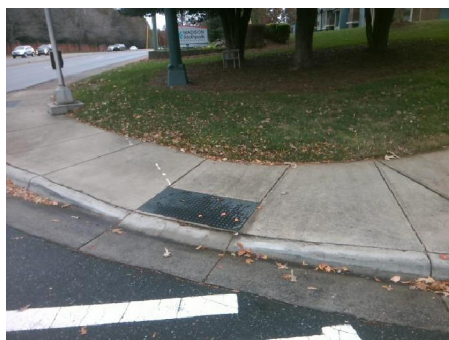
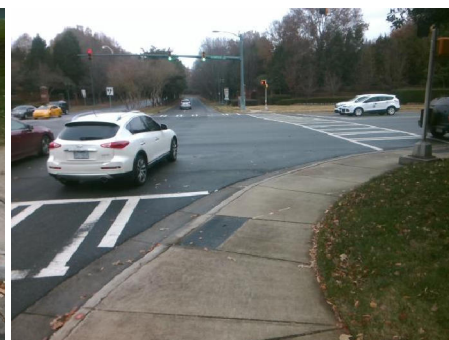
R304.5.3

Compliance	Description	Data	Compliance	Description	Data
N/A	Ramp Length (in)	73.0	Yes	Ramp Slope (%)	6.2
Yes	Ramp Width (in)	48.0	No	Ramp XSlope (%)	5.9
N/A	Flare Type LT	N/A	N/A	Flare Type RT	N/A
N/A	Flare Slope LT (%)	N/A	N/A	Flare Slope RT (%)	N/A
N/A	Flare Traversable LT?	N/A	N/A	Flare Traversable RT?	N/A
N/A	Landing Length (in)	N/A	N/A	DWS Provided?	N/A
N/A	Landing Width (in)	N/A	N/A	DWS Contrast?	N/A
N/A	Landing Slope (%)	N/A	N/A	DWS Length (in)	N/A
N/A	Landing X Slope (%)	N/A	N/A	DWS Full Width?	N/A
N/A	Landing Curb? (Y/N)	N/A	N/A	DWS Offset (in)	N/A
N/A	Shared Landing?	N/A			
N/A	Gutter Ponding?	N/A	N/A	Gutter Slope (%)	N/A
N/A	Gutter Lip Ht (in)	N/A	N/A	Gutter X Slope (%)	N/A
N/A	Painted X Walk1?	Yes	N/A	Painted X Walk2?	N/A
	X Walk 1 Direction	To SW		X Walk 2 Direction	N/A
N/A	X Walk 1 Width (in)	105.0	N/A	X Walk 2 Width (in)	N/A
	X Walk 1 Slope (%)	1.9		X Walk 2 Slope (%)	N/A
	X Walk 1 X Slope (%)	2.8		X Walk 2 X Slope (%)	N/A

N/A	Ramp inside XWalk1?	Yes	N/A	Ramp inside XWalk2?	N/A
	Road Slope (%)	N/A	N/A	Clear Space?	N/A
	Road X Slope (%)	N/A	N/A	Clear Space to XWalk (in)	N/A
N/A	Any Obstructions?	N/A	N/A	Storm Grate/Utility Hazard?	N/A
	Obstruction Type			Storm Grate/Utility Type	
		N/A			N/A
		Yes		Surface Condition? (G/P)	Good

Remove & Replace Entire Ramp.
