Access Compliance Report

Public Rights-of-Way

(Curb Ramps)

Intersection ID: 20552	Main Street: LUTOMMA_CR	Cross Street: SARDIS_RD	Location: NE
ADA ID: F2CDB21767BC	Ramp Type: Perp	Initial Pass/Fail: Fail	Overall Compliance: No
Codes/Mitigation Info/Possible Solution		Field Measurements/Component Compliance	
Severity Score: 12.5

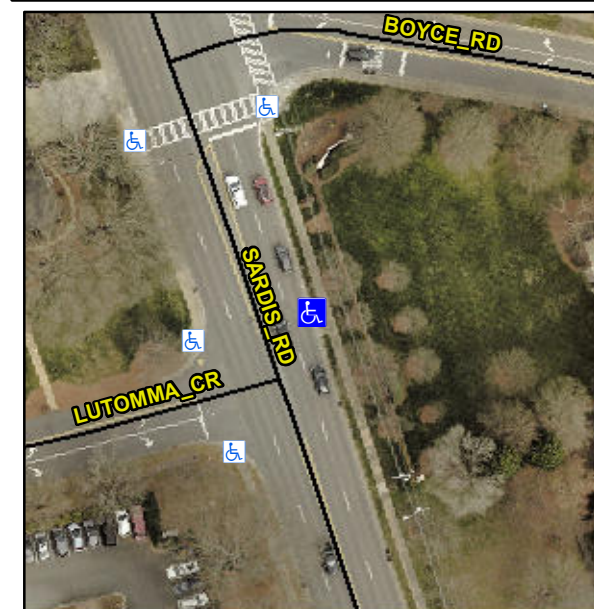
Not Found, R304.2.2

Compliance	Description	Data	Compliance	Description	Data
N/A	Ramp Length (in)	47.0	No	Ramp Slope (%)	8.9
Yes	Ramp Width (in)	72.0	Yes	Ramp XSlope (%)	1.7
N/A	Flare Type LT	N/A	N/A	Flare Type RT	N/A
N/A	Flare Slope LT (%)	N/A	N/A	Flare Slope RT (%)	N/A
N/A	Flare Traversable LT?	N/A	N/A	Flare Traversable RT?	N/A
N/A	Landing Length (in)	N/A	N/A	DWS Provided?	N/A
N/A	Landing Width (in)	N/A	N/A	DWS Contrast?	N/A
N/A	Landing Slope (%)	N/A	N/A	DWS Length (in)	N/A
N/A	Landing X Slope (%)	N/A	N/A	DWS Full Width?	N/A
N/A	Landing Curb? (Y/N)	N/A	N/A	DWS Offset (in)	N/A
N/A	Shared Landing?	N/A			
N/A	Gutter Ponding?	N/A	N/A	Gutter Slope (%)	N/A
N/A	Gutter Lip Ht (in)	N/A	N/A	Gutter X Slope (%)	N/A
N/A	Painted X Walk1?	No	N/A	Painted X Walk2?	N/A
	X Walk 1 Direction	To W		X Walk 2 Direction	N/A
N/A	X Walk 1 Width (in)	N/A	N/A	X Walk 2 Width (in)	N/A
	X Walk 1 Slope (%)	2.4		X Walk 2 Slope (%)	N/A
	X Walk 1 X Slope (%)	1.1		X Walk 2 X Slope (%)	N/A

N/A	Ramp inside XWalk1?	N/A	N/A	Ramp inside XWalk2?	N/A
	Road Slope (%)	N/A	N/A	Clear Space?	N/A
	Road X Slope (%)	N/A	N/A	Clear Space to XWalk (in)	N/A
N/A	Any Obstructions?	N/A	N/A	Storm Grate/Utility Hazard?	N/A
	Obstruction Type			Storm Grate/Utility Type	
		N/A			N/A
			Yes	Surface Condition? (G/P)	Good

Possible Solutions:

Remove & Replace Entire Ramp.
