Access Compliance Report

Public Rights-of-Way

(Curb Ramps)

Intersection ID: 45784	Main Street: CRABAPPLE_TREE_LN	Cross Street: LONG_HILL_DR	Location:	N
ADA ID: F2D485F32A9E	Ramp Type: Perp	Initial Pass/Fail: Fail	Overall Compliance: No	Severity Score: 12.5
Codes/Mitigation Info/Possible Solution		Field Measurements/Component Compliance

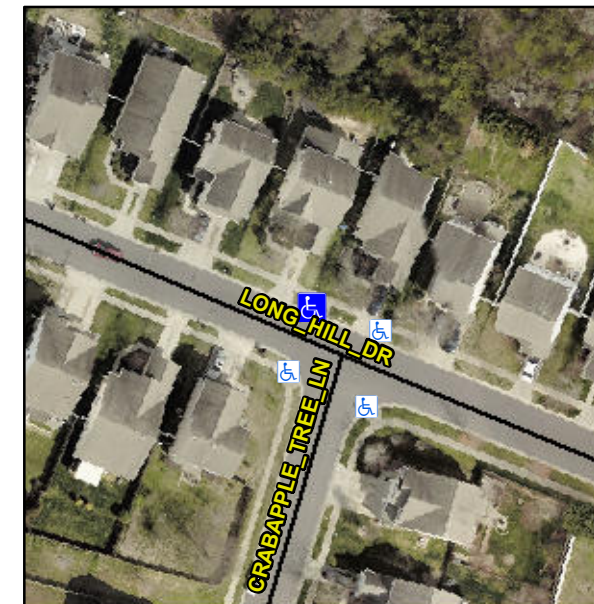
Not Found, R304.2.2

Compliance	Description	Data	Compliance	Description	Data
N/A	Ramp Length (in)	72.0	No	Ramp Slope (%)	8.4
Yes	Ramp Width (in)	48.0	Yes	Ramp XSlope (%)	0.6
N/A	Flare Type LT	N/A	N/A	Flare Type RT	N/A
N/A	Flare Slope LT (%)	N/A	N/A	Flare Slope RT (%)	N/A
N/A	Flare Traversable LT?	N/A	N/A	Flare Traversable RT?	N/A
N/A	Landing Length (in)	N/A	N/A	DWS Provided?	N/A
N/A	Landing Width (in)	N/A	N/A	DWS Contrast?	N/A
N/A	Landing Slope (%)	N/A	N/A	DWS Length (in)	N/A
N/A	Landing X Slope (%)	N/A	N/A	DWS Full Width?	N/A
N/A	Landing Curb? (Y/N)	N/A	N/A	DWS Offset (in)	N/A
N/A	Shared Landing?	N/A			
N/A	Gutter Ponding?	N/A	N/A	Gutter Slope (%)	N/A
N/A	Gutter Lip Ht (in)	N/A	N/A	Gutter X Slope (%)	N/A
N/A	Painted X Walk1?	No	N/A	Painted X Walk2?	N/A
	X Walk 1 Direction	To SW		X Walk 2 Direction	N/A
N/A	X Walk 1 Width (in)	N/A	N/A	X Walk 2 Width (in)	N/A
	X Walk 1 Slope (%)	1.4		X Walk 2 Slope (%)	N/A
	X Walk 1 X Slope (%)	0.8		X Walk 2 X Slope (%)	N/A

N/A	Ramp inside XWalk1?	N/A	N/A	Ramp inside XWalk2?	N/A
	Road Slope (%)	N/A	N/A	Clear Space?	N/A
	Road X Slope (%)	N/A	N/A	Clear Space to XWalk (in)	N/A
N/A	Any Obstructions?	N/A	N/A	Storm Grate/Utility Hazard?	N/A
	Obstruction Type			Storm Grate/Utility Type	
		N/A			N/A
			Yes	Surface Condition? (G/P)	Good

Possible Solutions:

Remove & Replace Entire Ramp.
