# Access Compliance Report

## Public Rights-of-Way

| Intersection ID: 27337 | Main Street: BALLANTYNE_MEADOWS_DR | Cross Street: DUCK_POND_CT | Location: NE |
| ADA ID: F2E08C4B7C04 | Ramp Type: PerpDiag | Initial Pass/Fail: Fail | Overall Compliance: No |

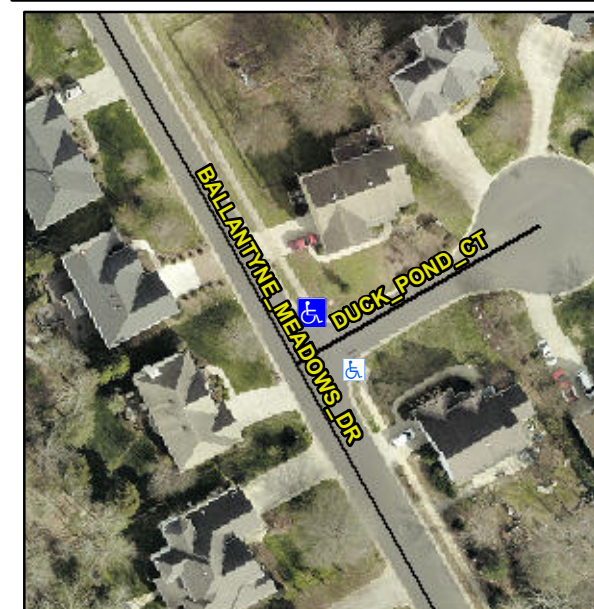
| Severity Score: 12.5 | | | |

| Compliance | Description | Data | Compliance | Description | Data |
|---|---|---|---|---|---|
| N/A | Ramp Length (in) | 97.0 | No | Ramp Slope (%) | 11.9 |

**Remove & Replace Curb Ramp With Two New Directional Ramps or Equivalent.**

**R304.2.2**

**\$ 3200.00**

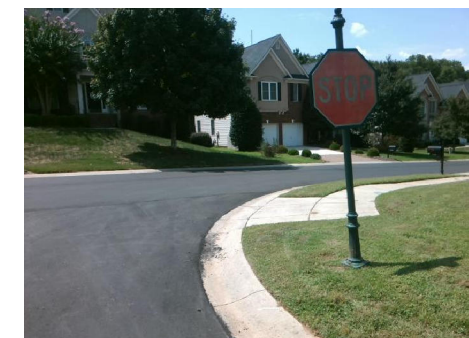
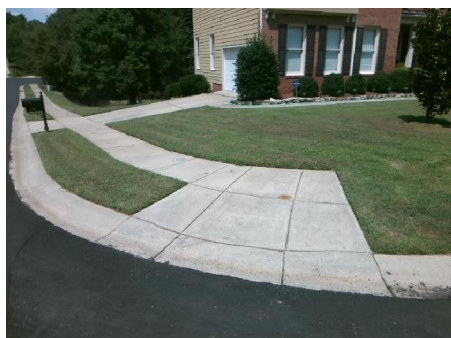
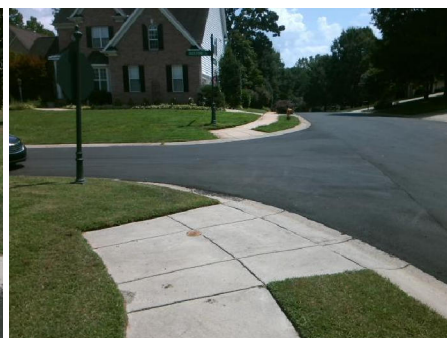
| Compliance | Description | Data | Compliance | Description | Data |
|---|---|---|---|---|---|
| Yes | Ramp Width (in) | 48.0 | Yes | Ramp XSlope (%) | 1.6 |
