Access Compliance Report

Public Rights-of-Way

(Curb Ramps)

Intersection ID: 13648	Main Street: SOUTHWOOD_AV	Cross Street: W_KINGSTON_AV	Location:	N
ADA ID: F2E309BB3474	Ramp Type: BlendTrans2	Initial Pass/Fail: Fail	Overall Compliance: No	Severity Score: 1.25

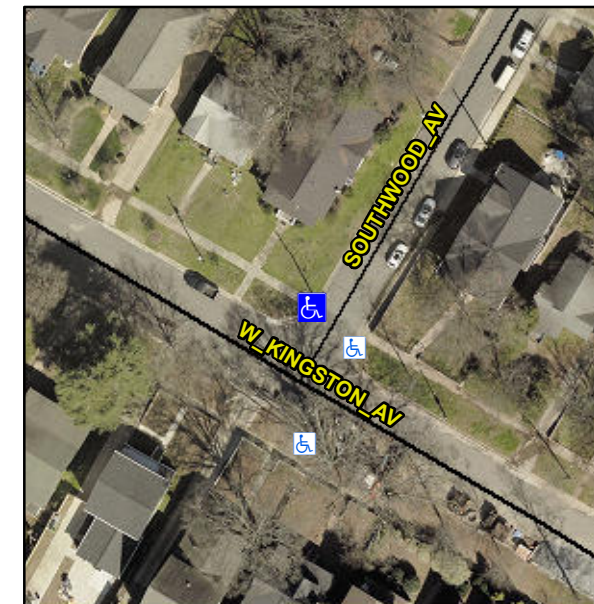
Compliance	Description	Data	Compliance	Description	Data
N/A	Ramp Length (in)	45.0	Yes	BlendTrans Slope (%)	0.6
Yes	Ramp Width (in)	57.0	No	BlendTrans XSlope (%)	2.1
N/A	Flare Type LT	N/A	N/A	Flare Type RT	N/A
N/A	Flare Slope LT (%)	N/A	N/A	Flare Slope RT (%)	N/A
N/A	Flare Traversable LT?	N/A	N/A	Flare Traversable RT?	N/A
N/A	Landing Length (in)	N/A	N/A	DWS Provided?	N/A
N/A	Landing Width (in)	N/A	N/A	DWS Contrast?	N/A
N/A	Landing Slope (%)	N/A	N/A	DWS Length (in)	N/A
N/A	Landing X Slope (%)	N/A	N/A	DWS Full Width?	N/A
N/A	Landing Curb? (Y/N)	N/A	N/A	DWS Offset (in)	N/A
N/A	Shared Landing?	N/A			
N/A	Gutter Ponding?	N/A	N/A	Gutter Slope (%)	N/A
N/A	Gutter Lip Ht (in)	N/A	N/A	Gutter X Slope (%)	N/A
N/A	Painted X Walk1?	No	N/A	Painted X Walk2?	N/A
	X Walk 1 Direction	To SE		X Walk 2 Direction	N/A
	X Walk 1 Width (in)	N/A		X Walk 2 Width (in)	N/A
	X Walk 1 Slope (%)	8.3		X Walk 2 Slope (%)	N/A
	X Walk 1 X Slope (%)	2.3		X Walk 2 X Slope (%)	N/A

N/A	Ramp inside XWalk1?	N/A	N/A	Ramp inside XWalk2?	N/A
	Road Slope (%)	2.3		Clear Space?	N/A
	Road X Slope (%)	8.3	N/A	Clear Space to XWalk (in)	N/A
N/A	Any Obstructions?	N/A	N/A	Storm Grate/Utility Hazard?	N/A
	Obstruction Type			Storm Grate/Utility Type	
		N/A			N/A
			Yes	Surface Condition? (G/P)	Good
			No	Curb Slope (%)	18.8

Remove & Replace Curb Ramp With Two New Directional Ramps or Equivalent.

Not Found, R304.5.3
