Access Compliance Report

Public Rights-of-Way

(Curb Ramps)

Intersection ID: 30154	Main Street: ALSTON_HILL_DR	Cross Street: RED_BUD_CR	Location: SW
ADA ID: F2E724BA31FE	Ramp Type: PerpDiag	Initial Pass/Fail: Fail	Overall Compliance: No
Severity Score: 22.5			
Codes/Mitigation Info/Possible Solution		Field Measurements/Component Compliance

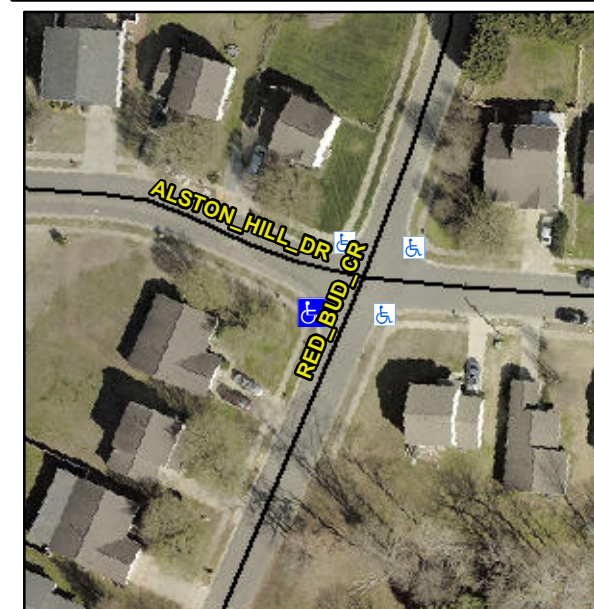
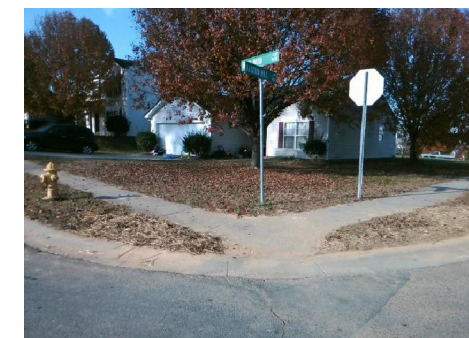
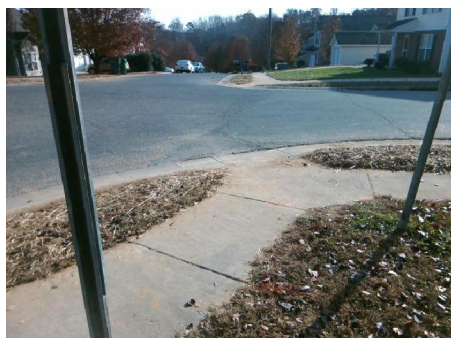
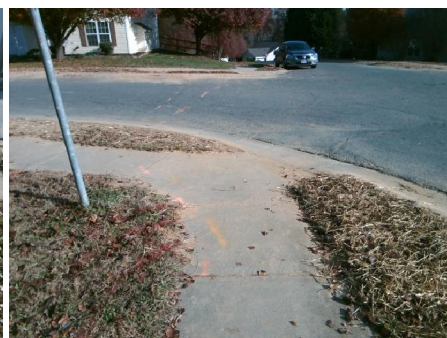
Compliance	Description	Data	Compliance	Description	Data
N/A	Ramp Length (in)	73.0	No	Ramp Slope (%)	8.4
No	Ramp Width (in)	43.0	No	Ramp XSlope (%)	2.7
N/A	Flare Type LT	N/A	N/A	Flare Type RT	N/A
N/A	Flare Slope LT (%)	N/A	N/A	Flare Slope RT (%)	N/A
N/A	Flare Traversable LT?	N/A	N/A	Flare Traversable RT?	N/A
N/A	Landing Length (in)	N/A	N/A	DWS Provided?	N/A
N/A	Landing Width (in)	N/A	N/A	DWS Contrast?	N/A
N/A	Landing Slope (%)	N/A	N/A	DWS Length (in)	N/A
N/A	Landing X Slope (%)	N/A	N/A	DWS Full Width?	N/A
N/A	Landing Curb? (Y/N)	N/A	N/A	DWS Offset (in)	N/A
N/A	Shared Landing?	N/A			
N/A	Gutter Ponding?	N/A	N/A	Gutter Slope (%)	N/A
N/A	Gutter Lip Ht (in)	1.0	N/A	Gutter X Slope (%)	N/A
N/A	Painted X Walk1?	No	N/A	Painted X Walk2?	No
	X Walk 1 Direction	To E		X Walk 2 Direction	To N
N/A	X Walk 1 Width (in)	N/A	N/A	X Walk 2 Width (in)	N/A
	X Walk 1 Slope (%)	0.5		X Walk 2 Slope (%)	1.6
	X Walk 1 X Slope (%)	3.1		X Walk 2 X Slope (%)	1.6

N/A	Ramp inside XWalk1?	N/A	N/A	Ramp inside XWalk2?	N/A
	Road Slope (%)	1.3	N/A	Clear Space?	N/A
	Road X Slope (%)	1.0	N/A	Clear Space to XWalk (in)	N/A
N/A	Any Obstructions?	N/A	N/A	Storm Grate/Utility Hazard?	N/A
	Obstruction Type			Storm Grate/Utility Type	
		N/A			N/A
			Yes	Surface Condition? (G/P)	Good

Remove & Replace Curb Ramp With Two New Directional Ramps or Equivalent.

R304.5.1, R304.2.2, R304.5.3
