Access Compliance Report Public Rights-of-Way (Curb Ramps)

Intersection ID: 14400 Main Street: BERKELEY_AV Cross Street: DILWORTH_RD Location: NW ADA ID: F2EB6B7072C9 **Overall Compliance: No** Ramp Type: Perp Initial Pass/Fail: Fail Severity Score: 13.75

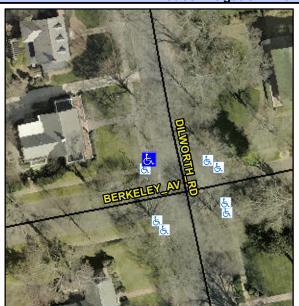
Field Measurements/Component Compliance								
Compl	iance Description	Data	Compl	iance Description	Data			
N/A	Ramp Length (in)	32.0	No	Ramp Slope (%)	9.4			
Yes	Ramp Width (in)	48.0	No	Ramp XSlope (%)	4.0			
N/A	Flare Type LT	N/A	N/A	Flare Type RT	N/A			
N/A	Flare Slope LT (%)	N/A	N/A	Flare Slope RT (%)	N/A			
N/A	Flare Traversable LT?	N/A	N/A	Flare Traversable RT?	N/A			
N/A	Landing Length (in)	N/A	N/A	DWS Provided?	N/A			
N/A	Landing Width (in)	N/A	N/A	DWS Contrast?	N/A			
N/A	Landing Slope (%)	N/A	N/A	DWS Length (in)	N/A			
N/A	Landing X Slope (%)	N/A	N/A	DWS Full Width?	N/A			
N/A	Landing Curb? (Y/N)	N/A	N/A	DWS Offset (in)	N/A			
N/A	Shared Landing?	N/A						
N/A	Gutter Ponding?	N/A	N/A	Gutter Slope (%)	N/A			
N/A	Gutter Lip Ht (in)	1.0	N/A	Gutter X Slope (%)	N/A			
N/A	Painted X Walk1?	No	N/A	Painted X Walk2?	N/A			
	X Walk 1 Direction	To E		X Walk 2 Direction	N/A			
N/A	X Walk 1 Width (in)	N/A	N/A	X Walk 2 Width (in)	N/A

X Walk 1 Slope (%)	7.8		X Walk 2 Slope (%)	N/A			
	X Walk 1 X Slope (%)	2.6		X Walk 2 X Slope (%)	N/A			
N/A	Ramp inside XWalk1?	N/A	N/A	Ramp inside XWalk2?	N/A			
	Road Slope (%)	N/A	N/A	Clear Space?	N/A			
	Road X Slope (%)	N/A	N/A	Clear Space to XWalk (in)	N/A			
N/A	Any Obstructions?	N/A	N/A	Storm Grate/Utility Hazard?	N/A			
	Obstruction Type			Storm Grate/Utility Type				
		N/A			N/A			
			Yes	Surface Condition? (G/P)	Good

Possible Solutions:	9
Remove & Replace Entire Ramp.	ı
	•
	ľ
	!
Surveyor Notes:	
N/A	·
	ı
	ı
	ı
PROW/ADA:	ı
Not Found, R304.2.2, R304.5.3	ı
	I
I	
	ı
