Access Compliance Report Public Rights-of-Way (Curb Ramps)

Intersection ID: 53963 Main Street: MAGNOLIA LILY AV **Cross Street: LILAC TREE AV** Location:

Overall Compliance: No ADA ID: F2EF78E60AE6 Ramp Type: BlendTrans1 Initial Pass/Fail: Fail Severity Score: 21.25

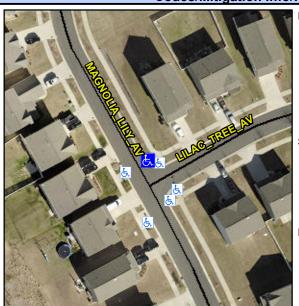
Not Found, R304.5.1, R304.5.3

Compliance Description Dat		Data	Comp	liance Description	Data
N/A	Ramp Length (in)	128.0	Yes	BlendTrans Slope (%)	2.7
No	Ramp Width (in)	42.0	No	BlendTrans XSlope (%)	6.6
N/A	Flare Type LT	N/A	N/A	Flare Type RT	N/A
N/A	Flare Slope LT (%)	N/A	N/A	Flare Slope RT (%)	N/A
N/A	Flare Traversable LT?	N/A	N/A	Flare Traversable RT?	N/A
N/A	Landing Length (in)	N/A	N/A	DWS Provided?	N/A
N/A	Landing Width (in)	N/A	N/A	DWS Contrast?	N/A
N/A	Landing Slope (%)	N/A	N/A	DWS Length (in)	N/A
N/A	Landing X Slope (%)	N/A	N/A	DWS Full Width?	N/A
N/A	Landing Curb? (Y/N)	N/A	N/A	DWS Offset (in)	N/A
N/A	Shared Landing?	N/A			
N/A	Gutter Ponding?	N/A	N/A	Gutter Slope (%)	N/A
N/A	Gutter Lip Ht (in)	2.0	N/A	Gutter X Slope (%)	N/A
N/A	Painted X Walk1?	No	N/A	Painted X Walk2?	N/A
	X Walk 1 Direction	To SE		X Walk 2 Direction	N/A
	X Walk 1 Width (in)	N/A		X Walk 2 Width (in)	N/A
	X Walk 1 Slope (%)	4.5		X Walk 2 Slope (%)	N/A
	X Walk 1 X Slope (%)	3.0		X Walk 2 X Slope (%)	N/A

N/A	Ramp inside XWalk1?	N/A	N/A	Ramp inside XWalk2?	N/A
	Road Slope (%)	3.0		Clear Space?	N/A
	Road X Slope (%)	4.5	N/A	Clear Space to XWalk (in)	N/A
N/A	Any Obstructions?	N/A	N/A	Storm Grate/Utility Hazard?	N/A
	Obstruction Type		l	Storm Grate/Utility Type	
		N/A	l		N/A
			Yes	Surface Condition? (G/P)	Good

Possible Solutions: Remove & Replace Curb Ramp With Two New Directional Ramps or Equivalent. Surveyor Notes: N/A
