Access Compliance Report

Public Rights-of-Way

(Curb Ramps)

Intersection ID: 10033675	Main Street: ORCHARD_LAKE_DR	Cross Street: N/A	Location: S
ADA ID: F2F15ED67B37	Ramp Type: BlendTrans1	Initial Pass/Fail: Fail	Overall Compliance: No
Severity Score: 1.25			
Codes/Mitigation Info/Possible Solution		Field Measurements/Component Compliance

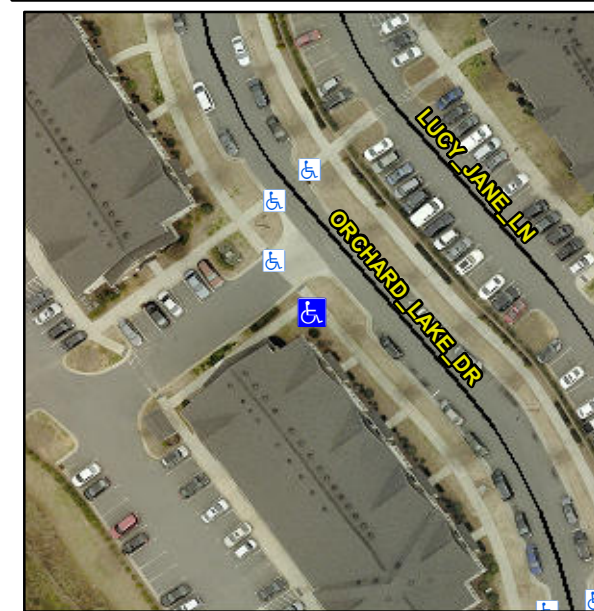
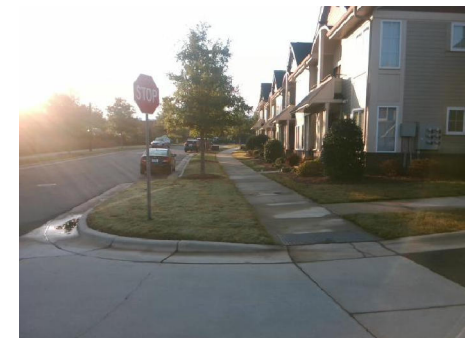
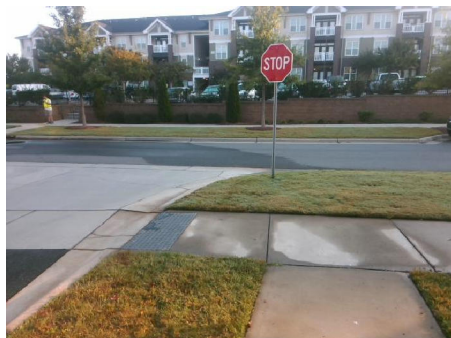
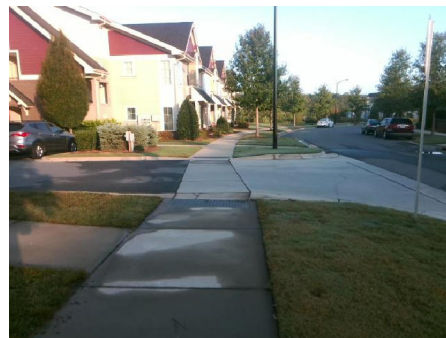
Not Found, R304.5.3

Compliance	Description	Data	Compliance	Description	Data
N/A	Ramp Length (in)	72.0	Yes	BlendTrans Slope (%)	4.2
Yes	Ramp Width (in)	73.0	No	BlendTrans XSlope (%)	3.8
N/A	Flare Type LT	N/A	N/A	Flare Type RT	N/A
N/A	Flare Slope LT (%)	N/A	N/A	Flare Slope RT (%)	N/A
N/A	Flare Traversable LT?	N/A	N/A	Flare Traversable RT?	N/A
N/A	Landing Length (in)	N/A	N/A	DWS Provided?	N/A
N/A	Landing Width (in)	N/A	N/A	DWS Contrast?	N/A
N/A	Landing Slope (%)	N/A	N/A	DWS Length (in)	N/A
N/A	Landing X Slope (%)	N/A	N/A	DWS Full Width?	N/A
N/A	Landing Curb? (Y/N)	N/A	N/A	DWS Offset (in)	N/A
N/A	Shared Landing?	N/A			
N/A	Gutter Ponding?	N/A	N/A	Gutter Slope (%)	N/A
N/A	Gutter Lip Ht (in)	N/A	N/A	Gutter X Slope (%)	N/A
N/A	Painted X Walk1?	No	N/A	Painted X Walk2?	N/A
	X Walk 1 Direction	To NW		X Walk 2 Direction	N/A
	X Walk 1 Width (in)	N/A		X Walk 2 Width (in)	N/A
	X Walk 1 Slope (%)	1.2		X Walk 2 Slope (%)	N/A
	X Walk 1 X Slope (%)	1.8		X Walk 2 X Slope (%)	N/A

N/A	Ramp inside XWalk1?	N/A	N/A	Ramp inside XWalk2?	N/A
	Road Slope (%)	1.8		Clear Space?	N/A
	Road X Slope (%)	1.2	N/A	Clear Space to XWalk (in)	N/A
N/A	Any Obstructions?	N/A	N/A	Storm Grate/Utility Hazard?	N/A
	Obstruction Type			Storm Grate/Utility Type	
		N/A			N/A
			Yes	Surface Condition? (G/P)	Good
			No	Curb Slope (%)	5.4

Possible Solutions:

Remove & Replace Curb Ramp With Two New Directional Ramps or Equivalent.
