Access Compliance Report

Public Rights-of-Way

(Curb Ramps)

Intersection ID: 26100	Main Street: FAIRCHILD_LN	Cross Street: HOLLY_HILL_FARM_RD	Location: SW
ADA ID: F2F9DB3128DD	Ramp Type: PerpDiag	Initial Pass/Fail: Fail	Overall Compliance: No
Codes/Mitigation Info/Possible Solution		Field Measurements/Component Compliance	
Severity Score: 13.75

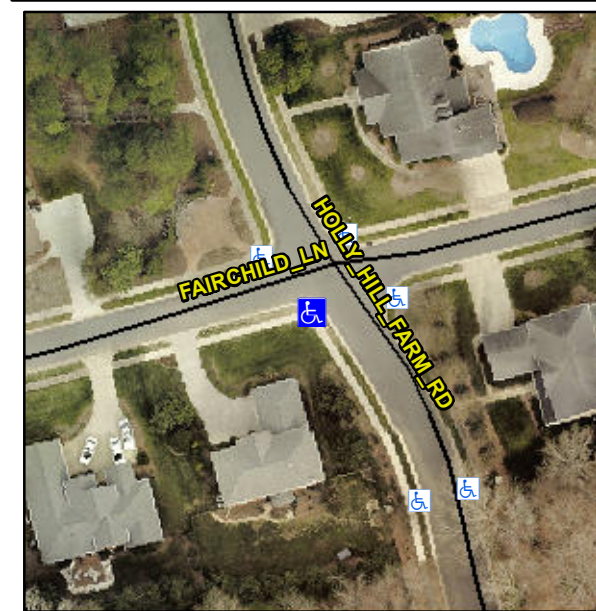
Compliance	Description	Data	Compliance	Description	Data
N/A	Ramp Length (in)	49.0	No	Ramp Slope (%)	8.6
Yes	Ramp Width (in)	48.0	No	Ramp XSlope (%)	3.7
N/A	Flare Type LT	N/A	N/A	Flare Type RT	N/A
N/A	Flare Slope LT (%)	N/A	N/A	Flare Slope RT (%)	N/A
N/A	Flare Traversable LT?	N/A	N/A	Flare Traversable RT?	N/A
N/A	Landing Length (in)	N/A	N/A	DWS Provided?	N/A
N/A	Landing Width (in)	N/A	N/A	DWS Contrast?	N/A
N/A	Landing Slope (%)	N/A	N/A	DWS Length (in)	N/A
N/A	Landing X Slope (%)	N/A	N/A	DWS Full Width?	N/A
N/A	Landing Curb? (Y/N)	N/A	N/A	DWS Offset (in)	N/A
N/A	Shared Landing?	N/A			
N/A	Gutter Ponding?	N/A	N/A	Gutter Slope (%)	N/A
N/A	Gutter Lip Ht (in)	N/A	N/A	Gutter X Slope (%)	N/A
N/A	Painted X Walk1?	No	N/A	Painted X Walk2?	No
	X Walk 1 Direction	To E		X Walk 2 Direction	To NW
N/A	X Walk 1 Width (in)	N/A	N/A	X Walk 2 Width (in)	N/A
	X Walk 1 Slope (%)	4.5		X Walk 2 Slope (%)	0.5
	X Walk 1 X Slope (%)	1.0		X Walk 2 X Slope (%)	3.5

N/A	Ramp inside XWalk1?	N/A	N/A	Ramp inside XWalk2?	N/A
	Road Slope (%)	0.2	N/A	Clear Space?	N/A
	Road X Slope (%)	3.9	N/A	Clear Space to XWalk (in)	N/A
N/A	Any Obstructions?	N/A	N/A	Storm Grate/Utility Hazard?	N/A
	Obstruction Type			Storm Grate/Utility Type	
		N/A			N/A
			Yes	Surface Condition? (G/P)	Good

Remove & Replace Curb Ramp With Two New Directional Ramps or Equivalent.
