Access Compliance Report

Public Rights-of-Way

(Curb Ramps)

| Intersection ID: 14273 | Main Street: BAXTER_ST | Cross Street: CHERRY_ST | Location: SE |

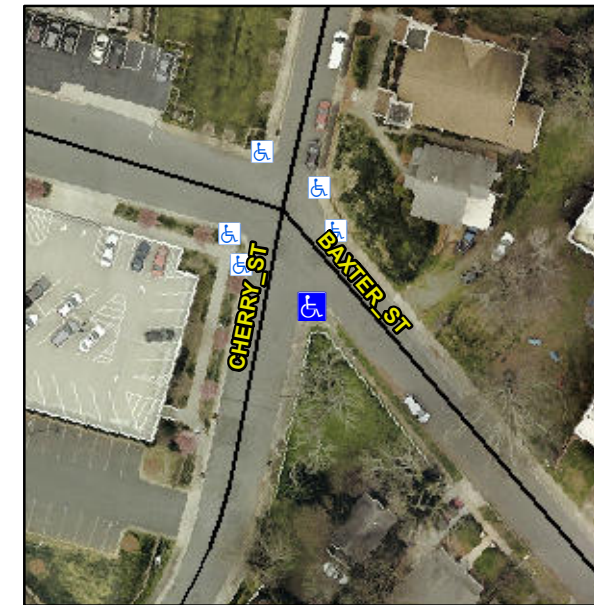
R304.5.1, R304.5.3

| Compliance | Description | Data | Compliance | Description | Data |
|---|---|---|---|---|---|
| N/A | Ramp Length (in) | 98.0 | Yes | Ramp Slope (%) | 7.2 |
| No | Ramp Width (in) | 41.0 | No | Ramp XSlope (%) | 10.3 |

Remove & Replace Curb Ramp With Two New Directional Ramps or Equivalent.
