# Access Compliance Report

## Public Rights-of-Way

### (Curb Ramps)

| Intersection ID: 17836 | Main Street: NORMANDY_RD | Cross Street: PENDER_PL | Location: SE |

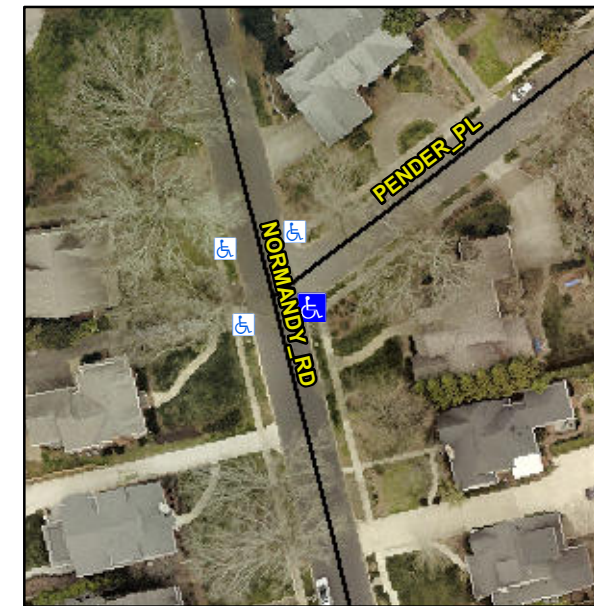
**Not Found, R304.5.3, R305.2, R304.5.4**

| Compliance | Description | Data | Compliance | Description | Data |
|---|---|---|---|---|---|
| Yes | Ramp Width (in) | 48.0 | No | Ramp XSlope (%) | 4.2 |
| No | Landing X Slope (%) | 4.4 | Yes | DWS Full Width? | Yes |
| N/A | Landing Curb? (Y/N) | No | No | DWS Offset (in) | 6.5 |
| Yes | Gutter Ponding? | No | No | Gutter Slope (%) | 9.9 |
| Yes | Gutter Lip Ht (in) | 0.0 | No | Gutter X Slope (%) | 3.1 |

**Remove & Replace Curb Ramp With Two New Directional Ramps or Equivalent. Remove & Replace Gutter.**
