Access Compliance Report

Public Rights-of-Way

(Curb Ramps)

Intersection ID: 1002822	Main Street: CASTLE_WATCH_AV	Cross Street: N/A	Location: SW
ADA ID: F31A5C12B4A1	Ramp Type: PerpDiag	Initial Pass/Fail: Fail	Overall Compliance: No
Severity Score: 48.75			
Codes/Mitigation Info/Possible Solution		Field Measurements/Component Compliance

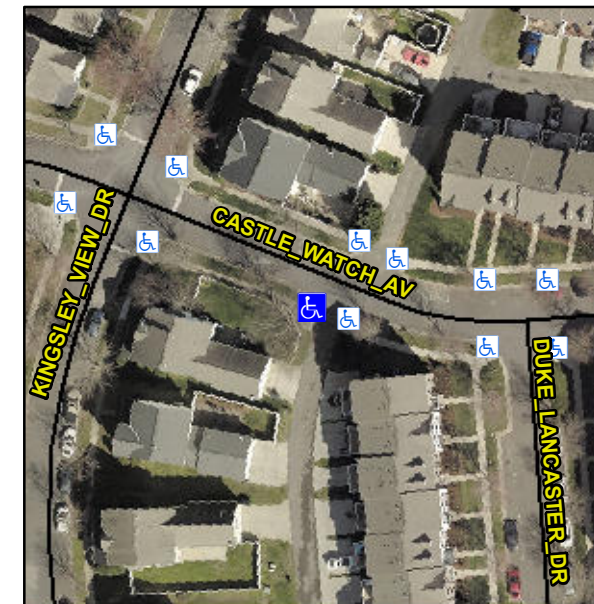
Compliance	Description	Data	Compliance	Description	Data
N/A	Ramp Length (in)	96.0	No	Ramp Slope (%)	8.6
No	Ramp Width (in)	26.0	No	Ramp XSlope (%)	4.9
N/A	Flare Type LT	N/A	N/A	Flare Type RT	N/A
N/A	Flare Slope LT (%)	N/A	N/A	Flare Slope RT (%)	N/A
N/A	Flare Traversable LT?	N/A	N/A	Flare Traversable RT?	N/A
N/A	Landing Length (in)	N/A	N/A	DWS Provided?	N/A
N/A	Landing Width (in)	N/A	N/A	DWS Contrast?	N/A
N/A	Landing Slope (%)	N/A	N/A	DWS Length (in)	N/A
N/A	Landing X Slope (%)	N/A	N/A	DWS Full Width?	N/A
N/A	Landing Curb? (Y/N)	N/A	N/A	DWS Offset (in)	N/A
N/A	Shared Landing?	N/A			
N/A	Gutter Ponding?	N/A	N/A	Gutter Slope (%)	N/A
N/A	Gutter Lip Ht (in)	N/A	N/A	Gutter X Slope (%)	N/A
N/A	Painted X Walk1?	No	N/A	Painted X Walk2?	No
	X Walk 1 Direction	To SE		X Walk 2 Direction	To NE
N/A	X Walk 1 Width (in)	N/A	N/A	X Walk 2 Width (in)	N/A
	X Walk 1 Slope (%)	5.9		X Walk 2 Slope (%)	4.2
	X Walk 1 X Slope (%)	3.9		X Walk 2 X Slope (%)	0.2

N/A	Ramp inside XWalk1?	N/A	N/A	Ramp inside XWalk2?	N/A
	Road Slope (%)	0.3	N/A	Clear Space?	N/A
	Road X Slope (%)	8.4	N/A	Clear Space to XWalk (in)	N/A
N/A	Any Obstructions?	N/A	N/A	Storm Grate/Utility Hazard?	N/A
	Obstruction Type			Storm Grate/Utility Type	
		N/A			N/A
			Yes	Surface Condition? (G/P)	Good

Possible Solutions:

Remove & Replace Curb Ramp With Two New Directional Ramps or Equivalent.

R304.5.1, R304.2.2, R304.5.3
