# Access Compliance Report

## Public Rights-of-Way

### (Curb Ramps)

Intersection ID: N/A	Main Street: MILLENNIUM_AV	Cross Street: CITY_PARK_DR	Location: SW
ADA ID: F31CDDDBFD2B7	Ramp Type: Directional1	Initial Pass/Fail: Fail	Overall Compliance: No
		Severity Score: 12.5

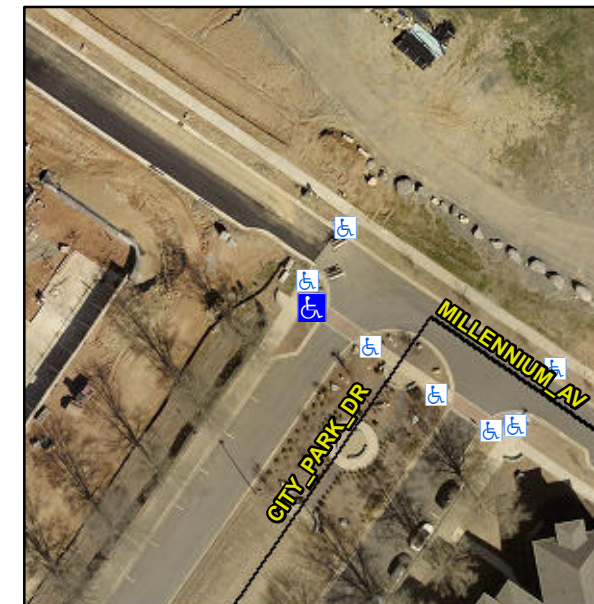
Compliance	Description	Data	Compliance	Description	Data
N/A	Ramp Length (in)	91.0	N/A	Grade Break?	N/A
Yes	Ramp Width (in)	70.0	N/A	Grade Break Slope (%)	0.0
No	Ramp Slope (%)	9.7	N/A	Grade Break XSlope (%)	0.0
Yes	Ramp XSlope (%)	0.0			
N/A	Flare Type LT	N/A	N/A	Flare Type RT	N/A
N/A	Flare Slope LT (%)	N/A	N/A	Flare Slope RT (%)	0.0
N/A	Flare Traversable LT?	N/A	N/A	Flare Traversable RT?	N/A
N/A	Landing Length (in)	0.0	N/A	DWS Provided?	N/A
N/A	Landing Width (in)	0.0	N/A	DWS Contrast?	N/A
N/A	Landing Slope (%)	0.0	N/A	DWS Length (in)	N/A
N/A	Landing X Slope (%)	0.0	N/A	DWS Full Width?	N/A
N/A	Landing Curb? (Y/N)	N/A	N/A	DWS Offset LT (in)	N/A
N/A	Shared Landing?	N/A	N/A	DWS Offset RT (in)	N/A
N/A	Gutter Ponding?	0.0	N/A	Gutter Slope (%)	N/A
N/A	Gutter Lip Ht (in)	0.0	N/A	Gutter X Slope (%)	N/A
N/A	Painted X Walk1?	Yes		Road Slope (%)	1.9
	X Walk 1 Direction	To SE		Road X Slope (%)	1.7
	X Walk 1 Width (in)	84.0		Clear Space?	N/A

X Walk 1 Slope (%)	1.9	N/A	Clear Space to XWalk (in)	N/A
	X Walk 1 X Slope (%)	1.7	N/A	Storm Grate/Utility Hazard?	N/A
N/A	Ramp inside XWalk1?	Yes		Storm Grate/Utility Type	
N/A	Any Obstructions?	N/A			N/A
	Obstruction Type		Yes	Surface Condition? (G/P)	Good
			N/A	Curb Slope (%)	9.0

**Remove & Replace Entire Ramp.**
