# Access Compliance Report

## Public Rights-of-Way

### (Curb Ramps)

Intersection ID: 49348	Main Street: HONEY_FIG_RD	Cross Street: FIRESPIKE_RD	Location: SE
ADA ID: F31FF5C89EA2	Ramp Type: Perp	Initial Pass/Fail: Fail	Overall Compliance: No
Severity Score: 8.75			
Codes/Mitigation Info/Possible Solution		Field Measurements/Component Compliance

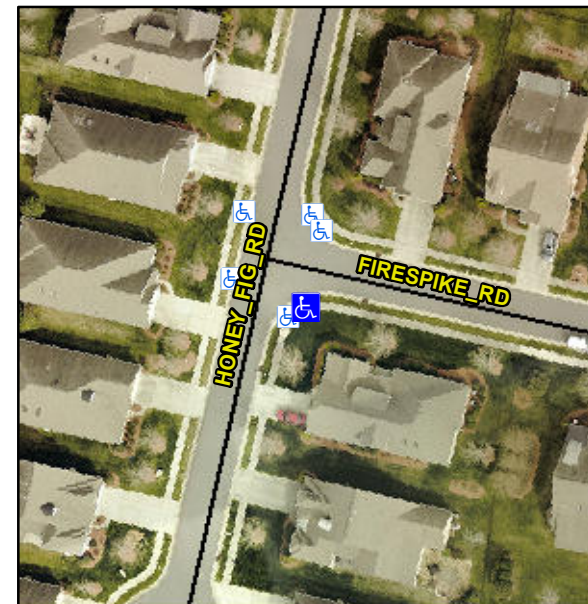
**R304.5.1**

Compliance	Description	Data	Compliance	Description	Data
N/A	Ramp Length (in)	47.0	Yes	Ramp Slope (%)	6.1
No	Ramp Width (in)	47.0	Yes	Ramp XSlope (%)	0.8
N/A	Flare Type LT	N/A	N/A	Flare Type RT	N/A
N/A	Flare Slope LT (%)	N/A	N/A	Flare Slope RT (%)	N/A
N/A	Flare Traversable LT?	N/A	N/A	Flare Traversable RT?	N/A
N/A	Landing Length (in)	N/A	N/A	DWS Provided?	N/A
N/A	Landing Width (in)	N/A	N/A	DWS Contrast?	N/A
N/A	Landing Slope (%)	N/A	N/A	DWS Length (in)	N/A
N/A	Landing X Slope (%)	N/A	N/A	DWS Full Width?	N/A
N/A	Landing Curb? (Y/N)	N/A	N/A	DWS Offset (in)	N/A
N/A	Shared Landing?	N/A			
N/A	Gutter Ponding?	N/A	N/A	Gutter Slope (%)	N/A
N/A	Gutter Lip Ht (in)	N/A	N/A	Gutter X Slope (%)	N/A
N/A	Painted X Walk1?	No	N/A	Painted X Walk2?	N/A
	X Walk 1 Direction	To NE		X Walk 2 Direction	N/A
N/A	X Walk 1 Width (in)	N/A	N/A	X Walk 2 Width (in)	N/A
	X Walk 1 Slope (%)	2.1		X Walk 2 Slope (%)	N/A
	X Walk 1 X Slope (%)	0.3		X Walk 2 X Slope (%)	N/A

N/A	Ramp inside XWalk1?	N/A	N/A	Ramp inside XWalk2?	N/A
	Road Slope (%)	N/A	N/A	Clear Space?	N/A
	Road X Slope (%)	N/A	N/A	Clear Space to XWalk (in)	N/A
N/A	Any Obstructions?	N/A	N/A	Storm Grate/Utility Hazard?	N/A
	Obstruction Type			Storm Grate/Utility Type	
		N/A			N/A
		Yes		Surface Condition? (G/P)	Good

**Remove & Replace Entire Ramp.**

Total Cost: \$ **1850.00**
