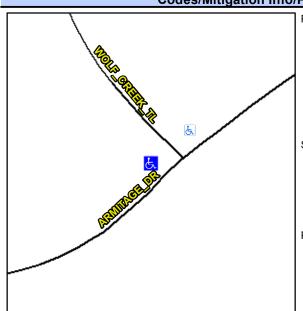
| Field Measurements/Component Compliance | | | | | |
|---|---|---|---|---|---|
| Yes | Landing Width (in) | 48.0 | Yes | DWS Contrast? | Yes |
| No | Landing Slope (%) | 4.4 | Yes | DWS Length (in) | 25.5 |
| Yes | Gutter Ponding? | No | Yes | Gutter Slope (%) | 3.7 |

WOLF CREEK TL Street 1 Name Stop Condition-Street 1 StopSign Street 2 Name N/A Stop Condition-Street 2 N/A Possible Solutions: Remove & Replace Entire Ramp. Remove & Replace Gutter. Surveyor Notes: N/A PROW/ADA: Not Found, R304.2.2-Perp, R304.3.2-Para, R304.5.3, R304.5.2, R305.2, R302.7.2
