Access Compliance Report

Public Rights-of-Way

(Curb Ramps)

Intersection ID: 16126		Main Street: E_W_T_HARRIS_BV		Cross Street: IDLEWILD_RD		Location: SE			
ADA ID: F32F6BF2A4C0		Ramp Type: Perp		Initial Pass/Fail: Fail		Overall Compliance: No		Severity Score: 50	
Codes/Mitigation Info/Possible Solution				Field Measurements/Component Compliance

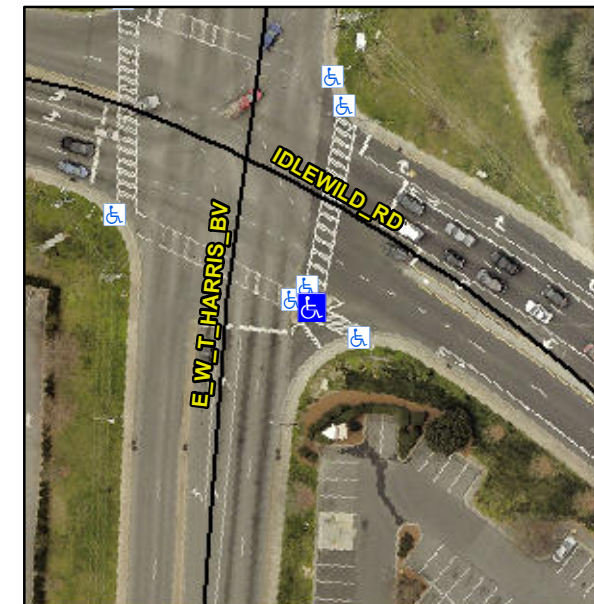
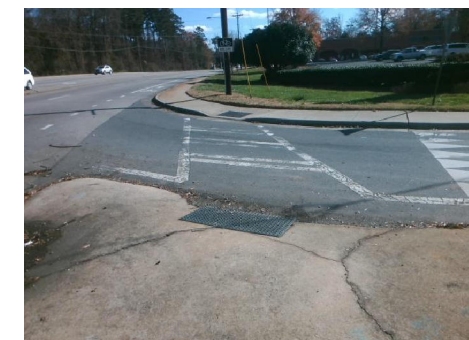
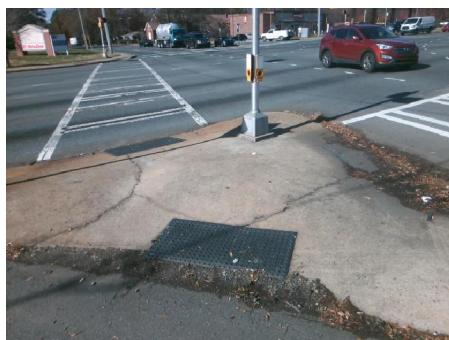
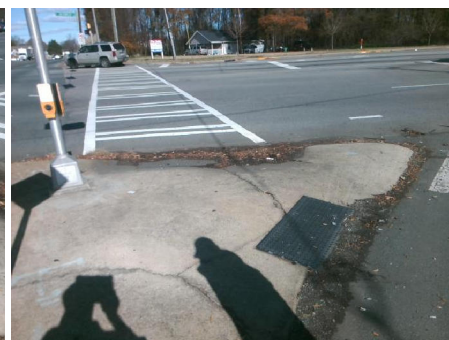
R304.2.2, R304.5.3

Compliance	Description	Data	Compliance	Description	Data
N/A	Ramp Length (in)	55.0	No	Ramp Slope (%)	12.2
Yes	Ramp Width (in)	48.0	No	Ramp XSlope (%)	7.1
N/A	Flare Type LT	N/A	N/A	Flare Type RT	N/A
N/A	Flare Slope LT (%)	N/A	N/A	Flare Slope RT (%)	N/A
N/A	Flare Traversable LT?	N/A	N/A	Flare Traversable RT?	N/A
N/A	Landing Length (in)	N/A	N/A	DWS Provided?	N/A
N/A	Landing Width (in)	N/A	N/A	DWS Contrast?	N/A
N/A	Landing Slope (%)	N/A	N/A	DWS Length (in)	N/A
N/A	Landing X Slope (%)	N/A	N/A	DWS Full Width?	N/A
N/A	Landing Curb? (Y/N)	N/A	N/A	DWS Offset (in)	N/A
N/A	Shared Landing?	N/A			
N/A	Gutter Ponding?	N/A	N/A	Gutter Slope (%)	N/A
N/A	Gutter Lip Ht (in)	N/A	N/A	Gutter X Slope (%)	N/A
N/A	Painted X Walk1?	Yes	N/A	Painted X Walk2?	N/A
	X Walk 1 Direction	To SE		X Walk 2 Direction	N/A
N/A	X Walk 1 Width (in)	91.0	N/A	X Walk 2 Width (in)	N/A
	X Walk 1 Slope (%)	0.8		X Walk 2 Slope (%)	N/A
	X Walk 1 X Slope (%)	1.2		X Walk 2 X Slope (%)	N/A

N/A	Ramp inside XWalk1?	Yes	N/A	Ramp inside XWalk2?	N/A
	Road Slope (%)	N/A	N/A	Clear Space?	N/A
	Road X Slope (%)	N/A	N/A	Clear Space to XWalk (in)	N/A
N/A	Any Obstructions?	N/A	N/A	Storm Grate/Utility Hazard?	N/A
	Obstruction Type			Storm Grate/Utility Type	
		N/A			N/A
			Yes	Surface Condition? (G/P)	Good

Remove & Replace Entire Ramp.
