# Access Compliance Report

## Public Rights-of-Way

### (Curb Ramps)

Intersection ID: 5563	Main Street: N I-77 EXIT 16 RA	Cross Street: REAMES_RD	Location: NE
ADA ID: F34FE8388DB4	Ramp Type: BlendTrans2	Initial Pass/Fail: Fail	Overall Compliance: No
Severity Score: 10			
Codes/Mitigation Info/Possible Solution		Field Measurements/Component Compliance

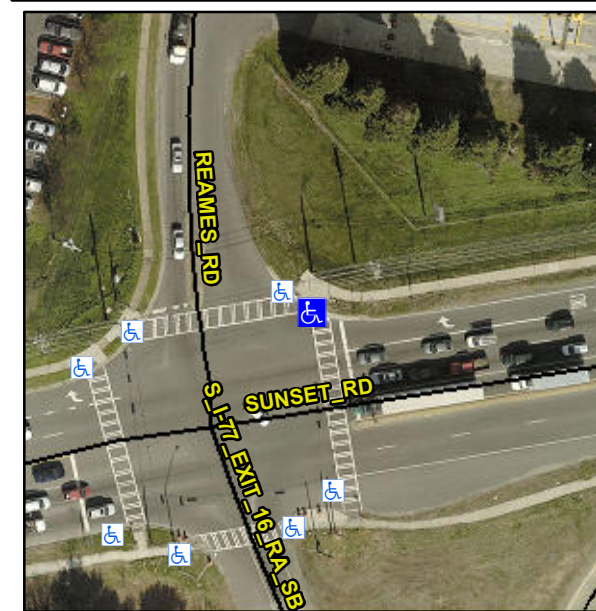
**Not Found, R304.5.1**

Compliance	Description	Data	Compliance	Description	Data
N/A	Ramp Length (in)	99.0	Yes	BlendTrans Slope (%)	4.3
No	Ramp Width (in)	47.0	Yes	BlendTrans XSlope (%)	3.2
N/A	Flare Type LT	N/A	N/A	Flare Type RT	N/A
N/A	Flare Slope LT (%)	N/A	N/A	Flare Slope RT (%)	N/A
N/A	Flare Traversable LT?	N/A	N/A	Flare Traversable RT?	N/A
N/A	Landing Length (in)	N/A	N/A	DWS Provided?	N/A
N/A	Landing Width (in)	N/A	N/A	DWS Contrast?	N/A
N/A	Landing Slope (%)	N/A	N/A	DWS Length (in)	N/A
N/A	Landing X Slope (%)	N/A	N/A	DWS Full Width?	N/A
N/A	Landing Curb? (Y/N)	N/A	N/A	DWS Offset (in)	N/A
N/A	Shared Landing?	N/A			
N/A	Gutter Ponding?	N/A	N/A	Gutter Slope (%)	N/A
N/A	Gutter Lip Ht (in)	N/A	N/A	Gutter X Slope (%)	N/A
N/A	Painted X Walk1?	Yes	N/A	Painted X Walk2?	N/A
	X Walk 1 Direction	To S		X Walk 2 Direction	N/A
	X Walk 1 Width (in)	112.0		X Walk 2 Width (in)	N/A
	X Walk 1 Slope (%)	2.8		X Walk 2 Slope (%)	N/A
	X Walk 1 X Slope (%)	4.2		X Walk 2 X Slope (%)	N/A

N/A	Ramp inside XWalk1?	Yes	N/A	Ramp inside XWalk2?	N/A
	Road Slope (%)	4.2		Clear Space?	N/A
	Road X Slope (%)	2.8	N/A	Clear Space to XWalk (in)	N/A
N/A	Any Obstructions?	N/A	N/A	Storm Grate/Utility Hazard?	N/A
	Obstruction Type			Storm Grate/Utility Type	
		N/A			N/A
			Yes	Surface Condition? (G/P)	Good
			No	Curb Slope (%)	9.7

Possible Solutions:

**Remove & Replace Curb Ramp With Two New Directional Ramps or Equivalent.**
