Access Compliance Report

Public Rights-of-Way

(Curb Ramps)

Intersection ID: 30054	Main Street: DAY_LILLY_LN	Cross Street: SOUTHWIND_DR	Location: W
ADA ID: F35511510CF3	Ramp Type: Perp	Initial Pass/Fail: Fail	Overall Compliance: No
		Severity Score: 25

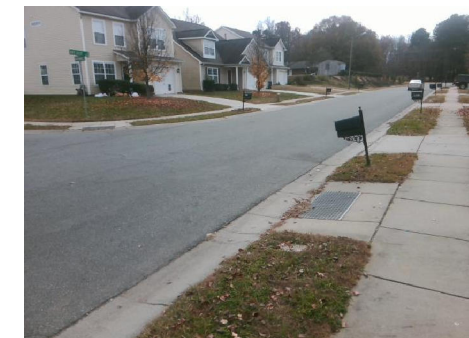
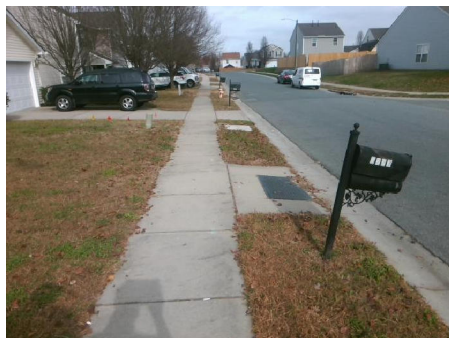
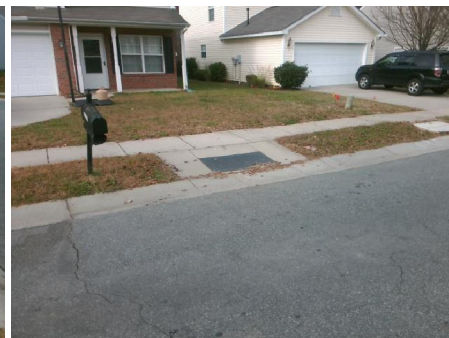
Compliance	Description	Data	Compliance	Description	Data
N/A	Ramp Length (in)	46.5	No	Ramp Slope (%)	12.4
Yes	Ramp Width (in)	48.0	Yes	Ramp XSlope (%)	1.4
N/A	Flare Type LT	N/A	N/A	Flare Type RT	N/A
N/A	Flare Slope LT (%)	N/A	N/A	Flare Slope RT (%)	N/A
N/A	Flare Traversable LT?	N/A	N/A	Flare Traversable RT?	N/A
N/A	Landing Length (in)	N/A	N/A	DWS Provided?	N/A
N/A	Landing Width (in)	N/A	N/A	DWS Contrast?	N/A
N/A	Landing Slope (%)	N/A	N/A	DWS Length (in)	N/A
N/A	Landing X Slope (%)	N/A	N/A	DWS Full Width?	N/A
N/A	Landing Curb? (Y/N)	N/A	N/A	DWS Offset (in)	N/A
N/A	Shared Landing?	N/A			
N/A	Gutter Ponding?	N/A	N/A	Gutter Slope (%)	N/A
N/A	Gutter Lip Ht (in)	N/A	N/A	Gutter X Slope (%)	N/A
N/A	Painted X Walk1?	No	N/A	Painted X Walk2?	N/A
	X Walk 1 Direction	To SE		X Walk 2 Direction	N/A
N/A	X Walk 1 Width (in)	N/A	N/A	X Walk 2 Width (in)	N/A
	X Walk 1 Slope (%)	2.6		X Walk 2 Slope (%)	N/A
	X Walk 1 X Slope (%)	0.9		X Walk 2 X Slope (%)	N/A

Remove & Replace Entire Ramp.
