# Access Compliance Report

## Public Rights-of-Way

### (Curb Ramps)

Intersection ID: 42786	Main Street: ERWIN_RIDGE_AV	Cross Street: FRANCES_GLEN_DR	Location: W
ADA ID: F369FC52BCED	Ramp Type: PerpDiag	Initial Pass/Fail: Fail	Overall Compliance: No
Severity Score: 47.5			
Codes/Mitigation Info/Possible Solution		Field Measurements/Component Compliance

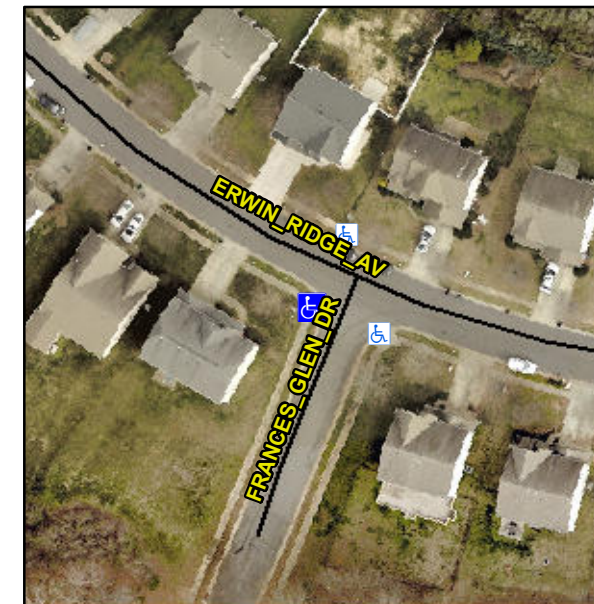
**Not Found, R304.5.1, R304.5.3**

Compliance	Description	Data	Compliance	Description	Data
N/A	Ramp Length (in)	47.0	Yes	Ramp Slope (%)	5.1
No	Ramp Width (in)	30.0	No	Ramp XSlope (%)	5.2
N/A	Flare Type LT	N/A	N/A	Flare Type RT	N/A
N/A	Flare Slope LT (%)	N/A	N/A	Flare Slope RT (%)	N/A
N/A	Flare Traversable LT?	N/A	N/A	Flare Traversable RT?	N/A
N/A	Landing Length (in)	N/A	N/A	DWS Provided?	N/A
N/A	Landing Width (in)	N/A	N/A	DWS Contrast?	N/A
N/A	Landing Slope (%)	N/A	N/A	DWS Length (in)	N/A
N/A	Landing X Slope (%)	N/A	N/A	DWS Full Width?	N/A
N/A	Landing Curb? (Y/N)	N/A	N/A	DWS Offset (in)	N/A
N/A	Shared Landing?	N/A			
N/A	Gutter Ponding?	N/A	N/A	Gutter Slope (%)	N/A
N/A	Gutter Lip Ht (in)	N/A	N/A	Gutter X Slope (%)	N/A
N/A	Painted X Walk1?	No	N/A	Painted X Walk2?	No
	X Walk 1 Direction	To S		X Walk 2 Direction	To E
N/A	X Walk 1 Width (in)	N/A	N/A	X Walk 2 Width (in)	N/A
	X Walk 1 Slope (%)	0.8		X Walk 2 Slope (%)	2.8
	X Walk 1 X Slope (%)	5.3		X Walk 2 X Slope (%)	0.3

N/A	Ramp inside XWalk1?	N/A	N/A	Ramp inside XWalk2?	N/A
	Road Slope (%)	2.1	N/A	Clear Space?	N/A
	Road X Slope (%)	2.4	N/A	Clear Space to XWalk (in)	N/A
N/A	Any Obstructions?	N/A	N/A	Storm Grate/Utility Hazard?	N/A
	Obstruction Type			Storm Grate/Utility Type	
		N/A			N/A
			Yes	Surface Condition? (G/P)	Good

**Remove & Replace Curb Ramp With Two New Directional Ramps or Equivalent.**
