Access Compliance Report

Public Rights-of-Way

(Curb Ramps)

Intersection ID: 46758	Main Street: CUMBERLAND COVE DR	Cross Street: SUPERIOR ST	Location: SW
ADA ID: F37359E132DC	Ramp Type: PerpDiag	Initial Pass/Fail: Fail	Overall Compliance: No
Severity Score: 8.75			
Codes/Mitigation Info/Possible Solution		Field Measurements/Component Compliance

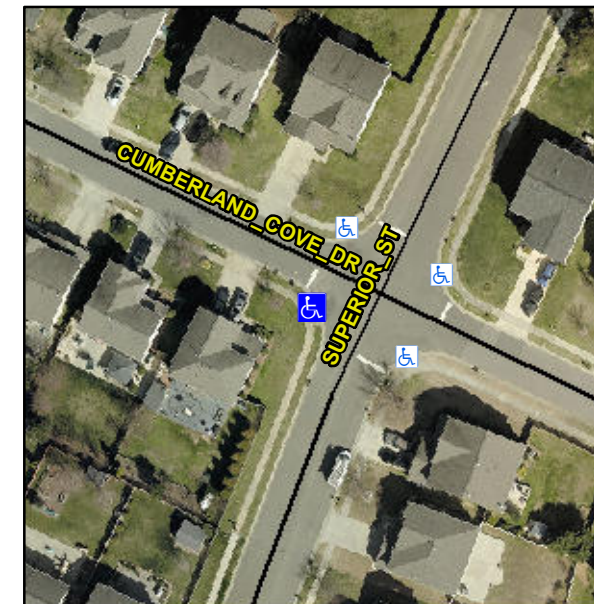
Compliance	Description	Data	Compliance	Description	Data
N/A	Ramp Length (in)	47.0	Yes	Ramp Slope (%)	5.4
No	Ramp Width (in)	40.0	Yes	Ramp XSlope (%)	0.6
N/A	Flare Type LT	N/A	N/A	Flare Type RT	N/A
N/A	Flare Slope LT (%)	N/A	N/A	Flare Slope RT (%)	N/A
N/A	Flare Traversable LT?	N/A	N/A	Flare Traversable RT?	N/A
N/A	Landing Length (in)	N/A	N/A	DWS Provided?	N/A
N/A	Landing Width (in)	N/A	N/A	DWS Contrast?	N/A
N/A	Landing Slope (%)	N/A	N/A	DWS Length (in)	N/A
N/A	Landing X Slope (%)	N/A	N/A	DWS Full Width?	N/A
N/A	Landing Curb? (Y/N)	N/A	N/A	DWS Offset (in)	N/A
N/A	Shared Landing?	N/A			
N/A	Gutter Ponding?	N/A	N/A	Gutter Slope (%)	N/A
N/A	Gutter Lip Ht (in)	N/A	N/A	Gutter X Slope (%)	N/A
N/A	Painted X Walk1?	No	N/A	Painted X Walk2?	No
	X Walk 1 Direction	To SE		X Walk 2 Direction	To NE
N/A	X Walk 1 Width (in)	N/A	N/A	X Walk 2 Width (in)	N/A
	X Walk 1 Slope (%)	0.5		X Walk 2 Slope (%)	1.9
	X Walk 1 X Slope (%)	0.5		X Walk 2 X Slope (%)	0.5

N/A	Ramp inside XWalk1?	N/A	N/A	Ramp inside XWalk2?	N/A
	Road Slope (%)	0.4	N/A	Clear Space?	N/A
	Road X Slope (%)	3.2	N/A	Clear Space to XWalk (in)	N/A
N/A	Any Obstructions?	N/A	N/A	Storm Grate/Utility Hazard?	N/A
	Obstruction Type			Storm Grate/Utility Type	
		N/A			N/A
			Yes	Surface Condition? (G/P)	Good

Possible Solutions:

Remove & Replace Curb Ramp With Two New Directional Ramps or Equivalent.

R304.5.1

Total Cost: \$ 3200.00
