Access Compliance Report Public Rights-of-Way (Curb Ramps)

Intersection ID: 20922 Main Street: COLONY RD **Cross Street: MAPLE GLENN LN** Location: SE ADA ID: F375BF6E7C32 Ramp Type: PerpDiag Initial Pass/Fail: Fail **Overall Compliance: No Severity Score:** 37.5

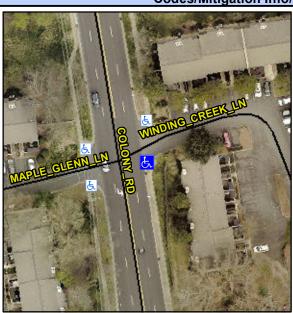
Comp	liance Description	Data	Comp	liance	Description	Data
N/A	Ramp Length (in)	67.0	No	Ramp	Slope (%)	9.0
Yes	Ramp Width (in)	48.0	No	Ramp	XSlope (%)	12.4
N/A	Flare Type LT	N/A	N/A	Flare	Type RT	N/A
N/A	Flare Slope LT (%)	N/A	N/A	Flare	Slope RT (%)	N/A
N/A	Flare Traversable LT?	N/A	N/A	Flare	Traversable RT?	N/A
N/A	Landing Length (in)	N/A	N/A	DWS	Provided?	N/A
N/A	Landing Width (in)	N/A	N/A	DWS	Contrast?	N/A
N/A	Landing Slope (%)	N/A	N/A	DWS	Length (in)	N/A
N/A	Landing X Slope (%)	N/A	N/A	DWS	Full Width?	N/A
N/A	Landing Curb? (Y/N)	N/A	N/A	DWS	Offset (in)	N/A
N/A	Shared Landing?	N/A				
N/A	Gutter Ponding?	N/A	N/A	Gutte	r Slope (%)	N/A
N/A	Gutter Lip Ht (in)	N/A	N/A	Gutte	r X Slope (%)	N/A
N/A	Painted X Walk1?	No	N/A	Painte	ed X Walk2?	No
	X Walk 1 Direction	To N		X Wa	lk 2 Direction	To W
N/A	X Walk 1 Width (in)	N/A	N/A	X Wa	lk 2 Width (in)	N/A
	X Walk 1 Slope (%)	2.6		X Wa	lk 2 Slope (%)	10.5
	X Walk 1 X Slope (%)	9.5		X Wa	lk 2 X Slope (%)	3.1

N/A	Ramp inside XWalk1?	N/A	N/A	Ramp	inside XWalk2?	N/A
	Road Slope (%)	5.8	N/A	Clear	Space?	N/A
	Road X Slope (%)	8.8	N/A	Clear	Space to XWalk (in)	N/A
N/A	Any Obstructions?	N/A	N/A	Storm	Grate/Utility Hazard?	N/A
	Obstruction Type		l	Storm	Grate/Utility Type	
		N/A				N/A
			Yes	Surfa	ce Condition? (G/P)	Good

Possible Solutions: Remove & Replace Curb Ramp With **Two New Directional Ramps or** Equivalent. Surveyor Notes: N/A PROW/ADA: Not Found, R304.2.2, R304.5.3
