Access Compliance Report

Public Rights-of-Way (Curb Ramps)

Intersection ID: 10040781	Main Street: W_TYVOLA_RD	Cross Street: N/A	Location: E
ADA ID: F3769583E374	Ramp Type: BlendTrans2	Initial Pass/Fail: Fail	Overall Compliance: No
Severity Score: 1.25			
Codes/Mitigation Info/Possible Solution		Field Measurements/Component Compliance

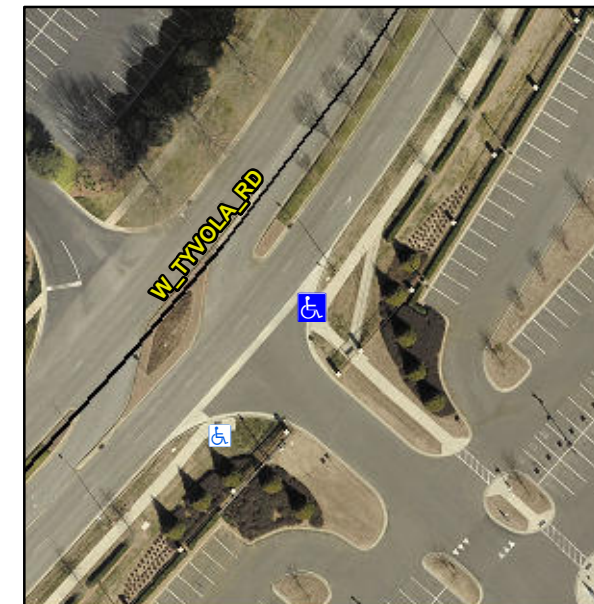
Not Found, R304.5.3

Compliance	Description	Data	Compliance	Description	Data
N/A	Ramp Length (in)	89.0	Yes	BlendTrans Slope (%)	2.2
Yes	Ramp Width (in)	48.0	No	BlendTrans XSlope (%)	2.4
N/A	Flare Type LT	N/A	N/A	Flare Type RT	N/A
N/A	Flare Slope LT (%)	N/A	N/A	Flare Slope RT (%)	N/A
N/A	Flare Traversable LT?	N/A	N/A	Flare Traversable RT?	N/A
N/A	Landing Length (in)	N/A	N/A	DWS Provided?	N/A
N/A	Landing Width (in)	N/A	N/A	DWS Contrast?	N/A
N/A	Landing Slope (%)	N/A	N/A	DWS Length (in)	N/A
N/A	Landing X Slope (%)	N/A	N/A	DWS Full Width?	N/A
N/A	Landing Curb? (Y/N)	N/A	N/A	DWS Offset (in)	N/A
N/A	Shared Landing?	N/A			
N/A	Gutter Ponding?	N/A	N/A	Gutter Slope (%)	N/A
N/A	Gutter Lip Ht (in)	N/A	N/A	Gutter X Slope (%)	N/A
N/A	Painted X Walk1?	No	N/A	Painted X Walk2?	N/A
	X Walk 1 Direction	To SW		X Walk 2 Direction	N/A
	X Walk 1 Width (in)	N/A		X Walk 2 Width (in)	N/A
	X Walk 1 Slope (%)	2.0		X Walk 2 Slope (%)	N/A
	X Walk 1 X Slope (%)	0.2		X Walk 2 X Slope (%)	N/A

N/A	Ramp inside XWalk1?	N/A	N/A	Ramp inside XWalk2?	N/A
	Road Slope (%)	0.2		Clear Space?	N/A
	Road X Slope (%)	2.0	N/A	Clear Space to XWalk (in)	N/A
N/A	Any Obstructions?	N/A	N/A	Storm Grate/Utility Hazard?	N/A
	Obstruction Type			Storm Grate/Utility Type	
		N/A			N/A
			Yes	Surface Condition? (G/P)	Good
			No	Curb Slope (%)	10.7

Remove & Replace Curb Ramp With Two New Directional Ramps or Equivalent.
