Access Compliance Report

Public Rights-of-Way

(Curb Ramps)

Intersection ID: 46931	Main Street: SYCAMORE GROVE CT	Cross Street: LIVERMORE LN	Location: NE
ADA ID: F387D4B51192	Ramp Type: PerpDiag	Initial Pass/Fail: Fail	Overall Compliance: No
Severity Score: 13.75			
Codes/Mitigation Info/Possible Solution		Field Measurements/Component Compliance

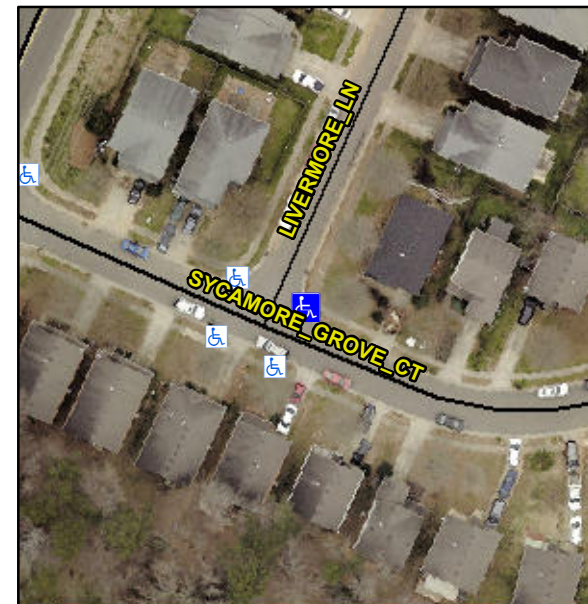
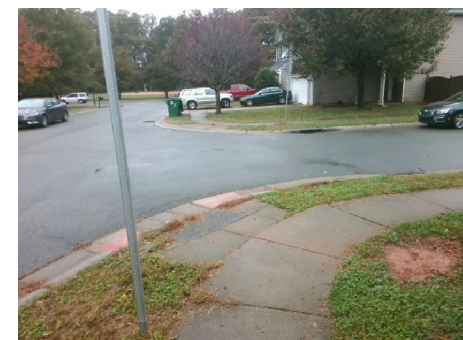
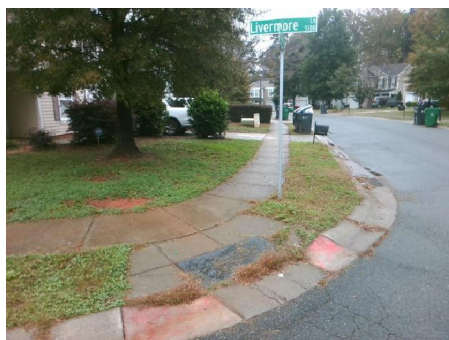
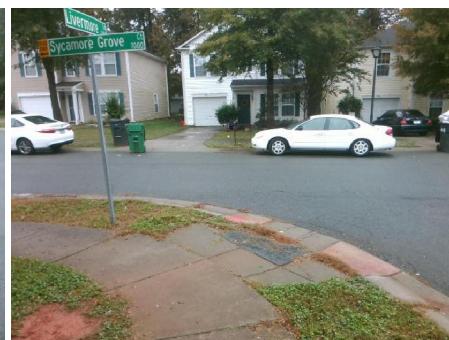
R304.2.2, R304.5.3

Compliance	Description	Data	Compliance	Description	Data
N/A	Ramp Length (in)	48.0	No	Ramp Slope (%)	10.7
Yes	Ramp Width (in)	48.0	No	Ramp XSlope (%)	4.8
N/A	Flare Type LT	N/A	N/A	Flare Type RT	N/A
N/A	Flare Slope LT (%)	N/A	N/A	Flare Slope RT (%)	N/A
N/A	Flare Traversable LT?	N/A	N/A	Flare Traversable RT?	N/A
N/A	Landing Length (in)	N/A	N/A	DWS Provided?	N/A
N/A	Landing Width (in)	N/A	N/A	DWS Contrast?	N/A
N/A	Landing Slope (%)	N/A	N/A	DWS Length (in)	N/A
N/A	Landing X Slope (%)	N/A	N/A	DWS Full Width?	N/A
N/A	Landing Curb? (Y/N)	N/A	N/A	DWS Offset (in)	N/A
N/A	Shared Landing?	N/A			
N/A	Gutter Ponding?	N/A	N/A	Gutter Slope (%)	N/A
N/A	Gutter Lip Ht (in)	N/A	N/A	Gutter X Slope (%)	N/A
N/A	Painted X Walk1?	No	N/A	Painted X Walk2?	No
	X Walk 1 Direction	To NW		X Walk 2 Direction	To SW
N/A	X Walk 1 Width (in)	N/A	N/A	X Walk 2 Width (in)	N/A
	X Walk 1 Slope (%)	0.5		X Walk 2 Slope (%)	2.6
	X Walk 1 X Slope (%)	0.9		X Walk 2 X Slope (%)	0.6

N/A	Ramp inside XWalk1?	N/A	N/A	Ramp inside XWalk2?	N/A
	Road Slope (%)	1.2	N/A	Clear Space?	N/A
	Road X Slope (%)	0.9	N/A	Clear Space to XWalk (in)	N/A
N/A	Any Obstructions?	N/A	N/A	Storm Grate/Utility Hazard?	N/A
	Obstruction Type			Storm Grate/Utility Type	
		N/A			N/A
			Yes	Surface Condition? (G/P)	Good

Remove & Replace Curb Ramp With Two New Directional Ramps or Equivalent.
