Access Compliance Report

Public Rights-of-Way

(Curb Ramps)

Intersection ID: 3522	Main Street: BRIMBERRY_CT	Cross Street: ROTHERHAM_LN	Location: SW
ADA ID: F388669FAE8D	Ramp Type: Perp	Initial Pass/Fail: Fail	Overall Compliance: No
Severity Score: 10			
Codes/Mitigation Info/Possible Solution		Field Measurements/Component Compliance

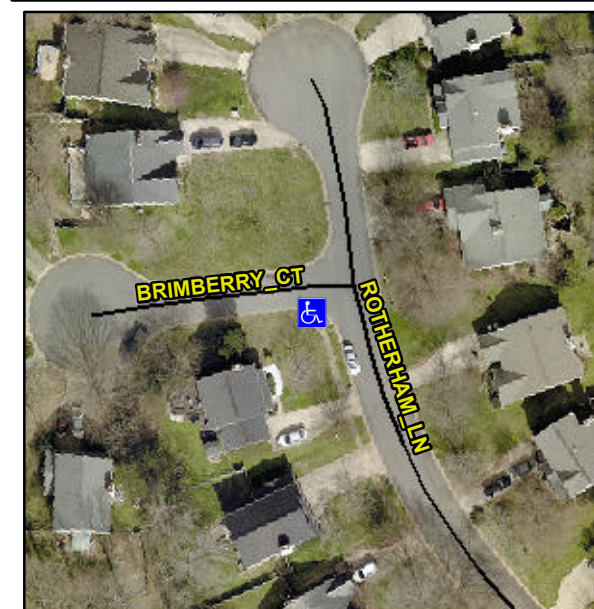
Not Found, R304.5.1, R304.5.3

Compliance	Description	Data	Compliance	Description	Data
N/A	Ramp Length (in)	91.0	Yes	Ramp Slope (%)	6.7
No	Ramp Width (in)	36.0	No	Ramp XSlope (%)	2.9
N/A	Flare Type LT	N/A	N/A	Flare Type RT	N/A
N/A	Flare Slope LT (%)	N/A	N/A	Flare Slope RT (%)	N/A
N/A	Flare Traversable LT?	N/A	N/A	Flare Traversable RT?	N/A
N/A	Landing Length (in)	N/A	N/A	DWS Provided?	N/A
N/A	Landing Width (in)	N/A	N/A	DWS Contrast?	N/A
N/A	Landing Slope (%)	N/A	N/A	DWS Length (in)	N/A
N/A	Landing X Slope (%)	N/A	N/A	DWS Full Width?	N/A
N/A	Landing Curb? (Y/N)	N/A	N/A	DWS Offset (in)	N/A
N/A	Shared Landing?	N/A			
N/A	Gutter Ponding?	N/A	N/A	Gutter Slope (%)	N/A
N/A	Gutter Lip Ht (in)	N/A	N/A	Gutter X Slope (%)	N/A
N/A	Painted X Walk1?	No	N/A	Painted X Walk2?	N/A
	X Walk 1 Direction	To N		X Walk 2 Direction	N/A
N/A	X Walk 1 Width (in)	N/A	N/A	X Walk 2 Width (in)	N/A
	X Walk 1 Slope (%)	3.2		X Walk 2 Slope (%)	N/A
	X Walk 1 X Slope (%)	2.7		X Walk 2 X Slope (%)	N/A

N/A	Ramp inside XWalk1?	N/A	N/A	Ramp inside XWalk2?	N/A
	Road Slope (%)	2.7	N/A	Clear Space?	N/A
	Road X Slope (%)	3.2	N/A	Clear Space to XWalk (in)	N/A
N/A	Any Obstructions?	N/A	N/A	Storm Grate/Utility Hazard?	N/A
	Obstruction Type			Storm Grate/Utility Type	
		N/A			N/A
			Yes	Surface Condition? (G/P)	Good

Possible Solutions:

Remove & Replace Entire Ramp.
