Access Compliance Report

Public Rights-of-Way

(Curb Ramps)

Intersection ID: 2798	Main Street: BLACKBIRD_CT	Cross Street: CHAVEL_LN	Location:	N
ADA ID: F390A3E4A084	Ramp Type: Perp	Initial Pass/Fail: Fail	Overall Compliance: No	Severity Score: 25

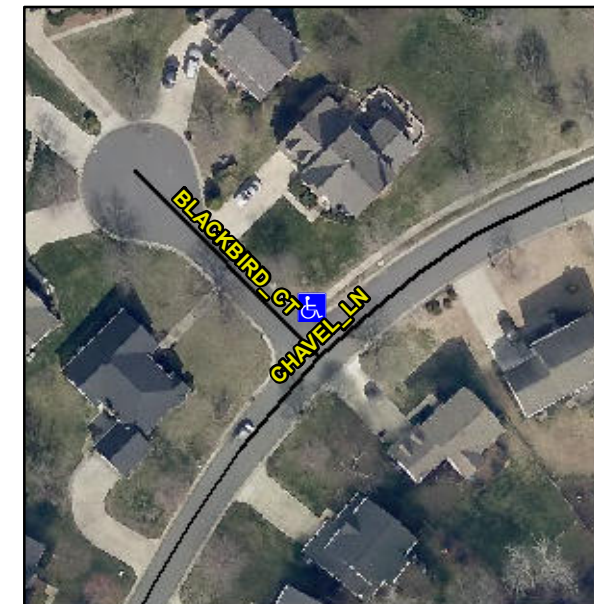
Not Found, R304.5.3

Compliance	Description	Data	Compliance	Description	Data
N/A	Ramp Length (in)	95.0	Yes	Ramp Slope (%)	5.5
Yes	Ramp Width (in)	48.0	No	Ramp XSlope (%)	7.1
N/A	Flare Type LT	N/A	N/A	Flare Type RT	N/A
N/A	Flare Slope LT (%)	N/A	N/A	Flare Slope RT (%)	N/A
N/A	Flare Traversable LT?	N/A	N/A	Flare Traversable RT?	N/A
N/A	Landing Length (in)	N/A	N/A	DWS Provided?	N/A
N/A	Landing Width (in)	N/A	N/A	DWS Contrast?	N/A
N/A	Landing Slope (%)	N/A	N/A	DWS Length (in)	N/A
N/A	Landing X Slope (%)	N/A	N/A	DWS Full Width?	N/A
N/A	Landing Curb? (Y/N)	N/A	N/A	DWS Offset (in)	N/A
N/A	Shared Landing?	N/A			
N/A	Gutter Ponding?	N/A	N/A	Gutter Slope (%)	N/A
N/A	Gutter Lip Ht (in)	N/A	N/A	Gutter X Slope (%)	N/A
N/A	Painted X Walk1?	No	N/A	Painted X Walk2?	N/A
	X Walk 1 Direction	To SW		X Walk 2 Direction	N/A
N/A	X Walk 1 Width (in)	N/A	N/A	X Walk 2 Width (in)	N/A
	X Walk 1 Slope (%)	5.2		X Walk 2 Slope (%)	N/A
	X Walk 1 X Slope (%)	1.7		X Walk 2 X Slope (%)	N/A

N/A	Ramp inside XWalk1?	N/A	N/A	Ramp inside XWalk2?	N/A
	Road Slope (%)	N/A	N/A	Clear Space?	N/A
	Road X Slope (%)	N/A	N/A	Clear Space to XWalk (in)	N/A
N/A	Any Obstructions?	N/A	N/A	Storm Grate/Utility Hazard?	N/A
	Obstruction Type			Storm Grate/Utility Type	
		N/A			N/A
			Yes	Surface Condition? (G/P)	Good

Remove & Replace Entire Ramp.
