Access Compliance Report Public Rights-of-Way (Curb Ramps)

Intersection ID: 15882 Main Street: EAST_BV Cross Street: QUEENS_RD_WEST Location: SE

ADA ID: F39546CFCB11 Ramp Type: PerpDiag Initial Pass/Fail: Fail Overall Compliance: No Severity Score: 26.25

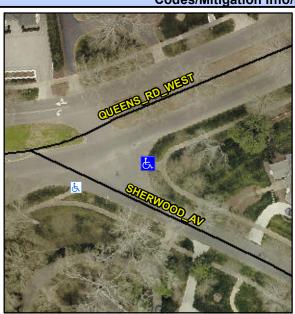
Compliance Description Dat		Data		liance Description	Data
N/A	Ramp Length (in)	180.0	No	Ramp Slope (%)	12.3
Yes	Ramp Width (in)	48.0	No	Ramp XSlope (%)	4.0
N/A	Flare Type LT	N/A	N/A	Flare Type RT	N/A
N/A	Flare Slope LT (%)	N/A	N/A	Flare Slope RT (%)	N/A
N/A	Flare Traversable LT?	N/A	N/A	Flare Traversable RT?	N/A
N/A	Landing Length (in)	N/A	N/A	DWS Provided?	N/A
N/A	Landing Width (in)	N/A	N/A	DWS Contrast?	N/A
N/A	Landing Slope (%)	N/A	N/A	DWS Length (in)	N/A
N/A	Landing X Slope (%)	N/A	N/A	DWS Full Width?	N/A
N/A	Landing Curb? (Y/N)	N/A	N/A	DWS Offset (in)	N/A
N/A	Shared Landing?	N/A			
N/A	Gutter Ponding?	N/A	N/A	Gutter Slope (%)	N/A
N/A	Gutter Lip Ht (in)	N/A	N/A	Gutter X Slope (%)	N/A
N/A	Painted X Walk1?	No	N/A	Painted X Walk2?	No
	X Walk 1 Direction	To N		X Walk 2 Direction	To W
N/A	X Walk 1 Width (in)	N/A	N/A	X Walk 2 Width (in)	N/A
	X Walk 1 Slope (%)	2.4		X Walk 2 Slope (%)	0.1
	X Walk 1 X Slope (%)	0.2		X Walk 2 X Slope (%)	3.8

N/A	Ramp inside XWalk1?	N/A	N/A	Ramp inside XWalk2?	N/A
	Road Slope (%)	4.4	N/A	Clear Space?	N/A
	Road X Slope (%)	1.7	N/A	Clear Space to XWalk (in)	N/A
N/A	Any Obstructions?	N/A	N/A	Storm Grate/Utility Hazard?	N/A
	Obstruction Type			Storm Grate/Utility Type	
		N/A			N/A
			Yes	Surface Condition? (G/P)	Good

Possible Solution	
Possible Solutions:	9
Remove & Replace Curb Ramp With	N
Two New Directional Ramps or	Υ
Equivalent.	N
	N
	N
	N
Surveyor Notes:	N
N/A	N
	N
	N
	N
PROW/ADA:	N
Not Found, R304.2.2, R304.5.3	N
	N
	N

Total Cost: \$ 3200.00
