# Access Compliance Report

## Public Rights-of-Way

| Intersection ID: 3050 | Main Street: SIX_POINT_LN | Cross Street: HARTINGTON_PL | Location: SE |
| ADA ID: F39BCC3662C2 | Ramp Type: BlendTrans1 | Initial Pass/Fail: Pass | Overall Compliance: No |

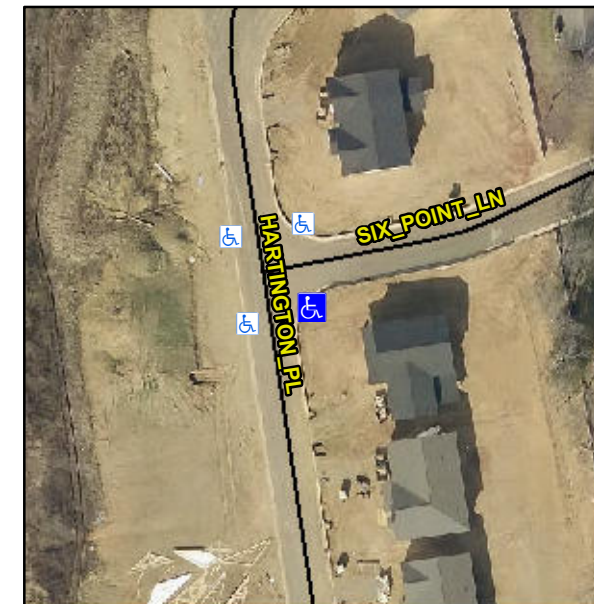
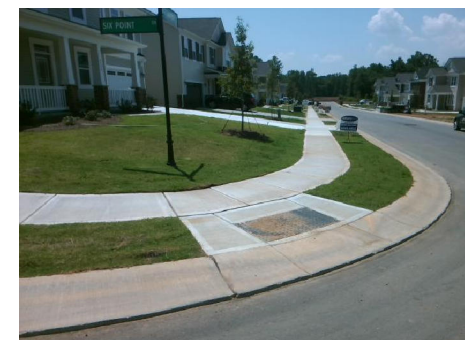
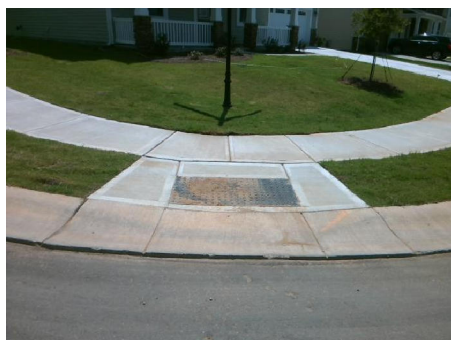
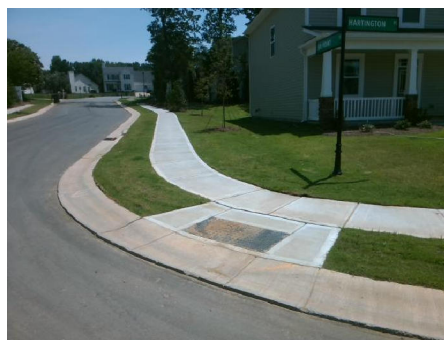
| | | Severity Score: 22.5 | |

**Not Found, R305.1.4, R305.2, R302.7.2, R304.5.4, R304.5.3**

| Compliance | Description | Data | Compliance | Description | Data |
|---|---|---|---|---|---|
| Yes | Landing X Slope (%) | 1.6 | No | DWS Full Width? | No |
| N/A | Landing Curb? (Y/N) | No | No | DWS Offset (in) | 4.5 |
| Yes | Gutter Ponding? | No | No | Gutter Slope (%) | 8.6 |
| No | Gutter Lip Ht (in) | 1.0 | No | Gutter X Slope (%) | 2.9 |

**Remove & Replace Curb Ramp With Two New Directional Ramps or Equivalent. Remove & Replace Gutter.**

Total Cost: \$ 3950.00
