Access Compliance Report

Public Rights-of-Way

(Curb Ramps)

Intersection ID: N/A	Main Street: E_W_T_HARRIS_BV	Cross Street: N/A	Location: SE
ADA ID: F39C6BB95838	Ramp Type: PerpDiag	Initial Pass/Fail: Fail	Overall Compliance: No
		Severity Score: 10

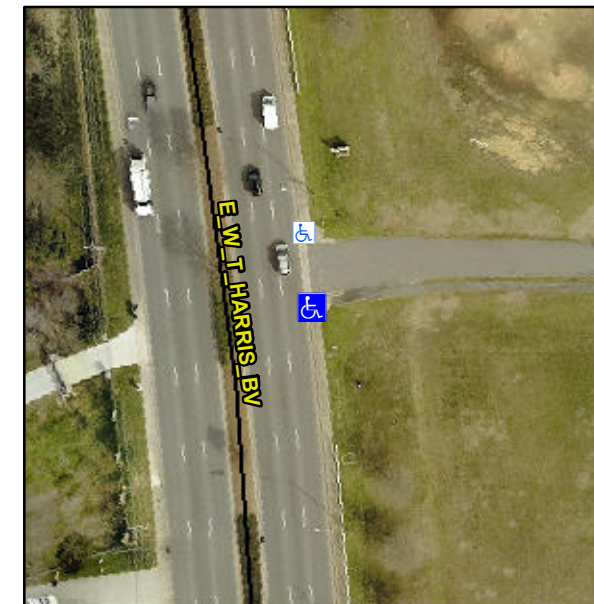
Not Found, R304.5.1

Compliance	Description	Data	Compliance	Description	Data
N/A	Ramp Length (in)	80.0	Yes	Ramp Slope (%)	6.5
No	Ramp Width (in)	40.0	Yes	Ramp XSlope (%)	3.7
N/A	Flare Type LT	N/A	N/A	Flare Type RT	N/A
N/A	Flare Slope LT (%)	N/A	N/A	Flare Slope RT (%)	N/A
N/A	Flare Traversable LT?	N/A	N/A	Flare Traversable RT?	N/A
N/A	Landing Length (in)	N/A	N/A	DWS Provided?	N/A
N/A	Landing Width (in)	N/A	N/A	DWS Contrast?	N/A
N/A	Landing Slope (%)	N/A	N/A	DWS Length (in)	N/A
N/A	Landing X Slope (%)	N/A	N/A	DWS Full Width?	N/A
N/A	Landing Curb? (Y/N)	N/A	N/A	DWS Offset (in)	N/A
N/A	Shared Landing?	N/A			
N/A	Gutter Ponding?	N/A	N/A	Gutter Slope (%)	N/A
N/A	Gutter Lip Ht (in)	N/A	N/A	Gutter X Slope (%)	N/A
N/A	Painted X Walk1?	No	N/A	Painted X Walk2?	No
	X Walk 1 Direction	To N		X Walk 2 Direction	To W
N/A	X Walk 1 Width (in)	N/A	N/A	X Walk 2 Width (in)	N/A
	X Walk 1 Slope (%)	2.0		X Walk 2 Slope (%)	3.8
	X Walk 1 X Slope (%)	3.3		X Walk 2 X Slope (%)	1.2

N/A	Ramp inside XWalk1?	N/A	N/A	Ramp inside XWalk2?	N/A
	Road Slope (%)	4.6	N/A	Clear Space?	N/A
	Road X Slope (%)	4.4	N/A	Clear Space to XWalk (in)	N/A
N/A	Any Obstructions?	N/A	N/A	Storm Grate/Utility Hazard?	N/A
	Obstruction Type			Storm Grate/Utility Type	
		N/A			N/A
			Yes	Surface Condition? (G/P)	Good

Remove & Replace Curb Ramp With Two New Directional Ramps or Equivalent.

Total Cost: \$ 3200.00
