Access Compliance Report

Public Rights-of-Way

(Curb Ramps)

Intersection ID: 10012530	Main Street: CARLEEN_WAY_DR	Cross Street: N/A	Location: SE
ADA ID: F3A5BDDA8C0A	Ramp Type: PerpDiag	Initial Pass/Fail: Fail	Overall Compliance: No
Codes/Mitigation Info/Possible Solution		Field Measurements/Component Compliance	
Severity Score: 8.75

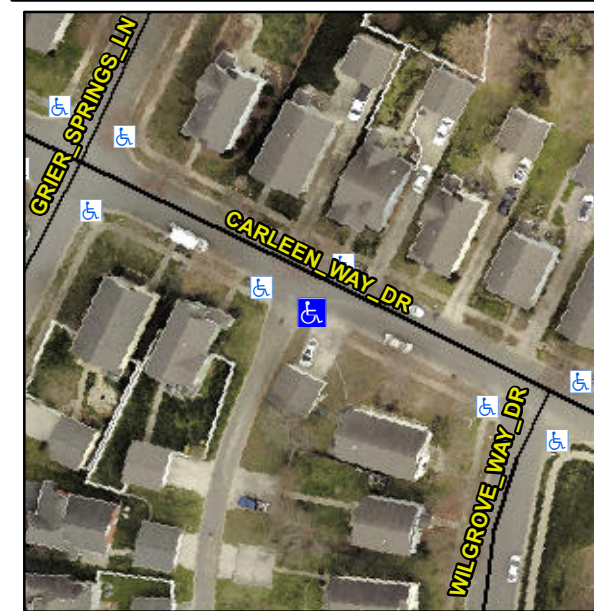
Not Found, R304.5.1

Compliance	Description	Data	Compliance	Description	Data
N/A	Ramp Length (in)	22.5	Yes	Ramp Slope (%)	8.1
No	Ramp Width (in)	44.5	Yes	Ramp XSlope (%)	0.2
N/A	Flare Type LT	N/A	N/A	Flare Type RT	N/A
N/A	Flare Slope LT (%)	N/A	N/A	Flare Slope RT (%)	N/A
N/A	Flare Traversable LT?	N/A	N/A	Flare Traversable RT?	N/A
N/A	Landing Length (in)	N/A	N/A	DWS Provided?	N/A
N/A	Landing Width (in)	N/A	N/A	DWS Contrast?	N/A
N/A	Landing Slope (%)	N/A	N/A	DWS Length (in)	N/A
N/A	Landing X Slope (%)	N/A	N/A	DWS Full Width?	N/A
N/A	Landing Curb? (Y/N)	N/A	N/A	DWS Offset (in)	N/A
N/A	Shared Landing?	N/A			
N/A	Gutter Ponding?	N/A	N/A	Gutter Slope (%)	N/A
N/A	Gutter Lip Ht (in)	N/A	N/A	Gutter X Slope (%)	N/A
N/A	Painted X Walk1?	No	N/A	Painted X Walk2?	No
	X Walk 1 Direction	To NE		X Walk 2 Direction	To NW
N/A	X Walk 1 Width (in)	N/A	N/A	X Walk 2 Width (in)	N/A
	X Walk 1 Slope (%)	4.2		X Walk 2 Slope (%)	2.0
	X Walk 1 X Slope (%)	1.3		X Walk 2 X Slope (%)	0.4

N/A	Ramp inside XWalk1?	N/A	N/A	Ramp inside XWalk2?	N/A
	Road Slope (%)	3.0	N/A	Clear Space?	N/A
	Road X Slope (%)	0.9	N/A	Clear Space to XWalk (in)	N/A
N/A	Any Obstructions?	N/A	N/A	Storm Grate/Utility Hazard?	N/A
	Obstruction Type			Storm Grate/Utility Type	
		N/A			N/A
			Yes	Surface Condition? (G/P)	Good

Remove & Replace Curb Ramp With Two New Directional Ramps or Equivalent.
