Access Compliance Report Public Rights-of-Way (Curb Ramps)

Intersection ID: 42944Main Street: TURNING_WHEEL_DRCross Street: SONOMA_VALLEY_DRLocation:NWADA ID: F3A78CD4F666Ramp Type: PerpInitial Pass/Fail: FailOverall Compliance: NoSeverity Score:10

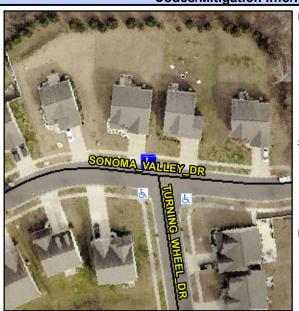
Field Measurements/Component Compliance							
Compliance Description		Data	Compliance Description		Data		
N/A	Ramp Length (in)	72.0	Yes	Ramp Slope (%)	7.1		
No	Ramp Width (in)	47.0	No	Ramp XSlope (%)	2.2		
N/A	Flare Type LT	N/A	N/A	Flare Type RT	N/A		
N/A	Flare Slope LT (%)	N/A	N/A	Flare Slope RT (%)	N/A		
N/A	Flare Traversable LT?	N/A	N/A	Flare Traversable RT?	N/A		
N/A	Landing Length (in)	N/A	N/A	DWS Provided?	N/A		
N/A	Landing Width (in)	N/A	N/A	DWS Contrast?	N/A		
N/A	Landing Slope (%)	N/A	N/A	DWS Length (in)	N/A		
N/A	Landing X Slope (%)	N/A	N/A	DWS Full Width?	N/A		
N/A	Landing Curb? (Y/N)	N/A	N/A	DWS Offset (in)	N/A		
N/A	Shared Landing?	N/A					
N/A	Gutter Ponding?	N/A	N/A	Gutter Slope (%)	N/A		
N/A	Gutter Lip Ht (in)	N/A	N/A	Gutter X Slope (%)	N/A		
N/A	Painted X Walk1?	No	N/A	Painted X Walk2?	N/A		
	X Walk 1 Direction	To S		X Walk 2 Direction	N/A		
N/A	X Walk 1 Width (in)	N/A	N/A	X Walk 2 Width (in)	N/A

X Walk 1 Slope (%)	3.1		X Walk 2 Slope (%)	N/A		
	X Walk 1 X Slope (%)	1.5		X Walk 2 X Slope (%)	N/A		
N/A	Ramp inside XWalk1?	N/A	N/A	Ramp inside XWalk2?	N/A		
	Road Slope (%)	N/A	N/A	Clear Space?	N/A		
	Road X Slope (%)	N/A	N/A	Clear Space to XWalk (in)	N/A		
N/A	Any Obstructions?	N/A	N/A	Storm Grate/Utility Hazard?	N/A		
	Obstruction Type			Storm Grate/Utility Type			
		N/A			N/A		
			Yes	Surface Condition? (G/P)	Good

Possible Solutions:	9		
Remove & Replace Entire Ramp.			
	N		
	N		
	N		
	N		
	N		
Surveyor Notes:	N		
N/A	N		
	N		
	N		
	N		
PROW/ADA:	N		
Not Found, R304.5.1, R304.5.3	N		
	N		
	N		
	N
