Intersection ID: 10026002	Main Street: ELMSTONE_DR	Cross Street: N/A	Location:	SE
ADA ID: F3AA5CCF83A0	Ramp Type: PerpDiag	Initial Pass/Fail: Fail	Overall Compliance: No	Severity Score: 37.5

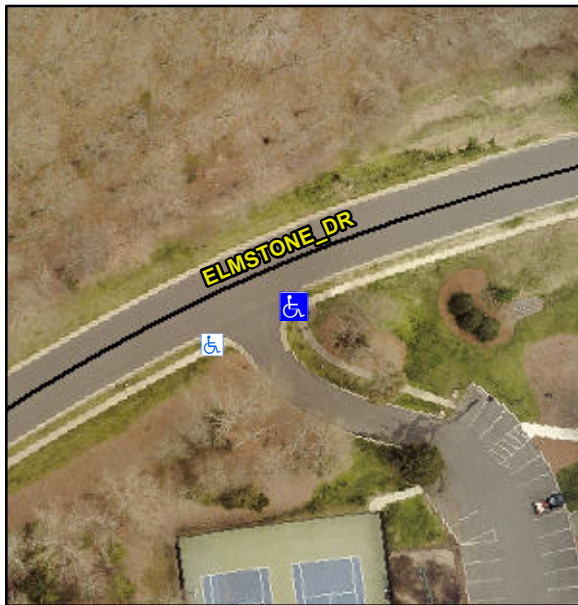
**Not Found, R304.2.2, R304.5.3**

Compliance	Description	Data	Compliance	Description	Data
N/A	Ramp Length (in)	48.0	No	Ramp Slope (%)	11.3
Yes	Ramp Width (in)	48.0	No	Ramp XSlope (%)	7.7
N/A	Flare Type LT	N/A	N/A	Flare Type RT	N/A
N/A	Flare Slope LT (%)	N/A	N/A	Flare Slope RT (%)	N/A
N/A	Flare Traversable LT?	N/A	N/A	Flare Traversable RT?	N/A
N/A	Landing Length (in)	N/A	N/A	DWS Provided?	N/A
N/A	Landing Width (in)	N/A	N/A	DWS Contrast?	N/A
N/A	Landing Slope (%)	N/A	N/A	DWS Length (in)	N/A
N/A	Landing X Slope (%)	N/A	N/A	DWS Full Width?	N/A
N/A	Landing Curb? (Y/N)	N/A	N/A	DWS Offset (in)	N/A
N/A	Shared Landing?	N/A			
N/A	Gutter Ponding?	N/A	N/A	Gutter Slope (%)	N/A
N/A	Gutter Lip Ht (in)	N/A	N/A	Gutter X Slope (%)	N/A
N/A	Painted X Walk1?	No	N/A	Painted X Walk2?	No
	X Walk 1 Direction	To N		X Walk 2 Direction	To W
N/A	X Walk 1 Width (in)	N/A	N/A	X Walk 2 Width (in)	N/A
	X Walk 1 Slope (%)	0.9		X Walk 2 Slope (%)	6.5
	X Walk 1 X Slope (%)	5.5		X Walk 2 X Slope (%)	2.6

N/A	Ramp inside XWalk1?	N/A	N/A	Ramp inside XWalk2?	N/A
	Road Slope (%)	6.4	N/A	Clear Space?	N/A
	Road X Slope (%)	5.0	N/A	Clear Space to XWalk (in)	N/A
N/A	Any Obstructions?	N/A	N/A	Storm Grate/Utility Hazard?	N/A
	Obstruction Type			Storm Grate/Utility Type	
		N/A			N/A
			Yes	Surface Condition? (G/P)	Good

**Remove & Replace Curb Ramp With Two New Directional Ramps or Equivalent.**
