# Access Compliance Report

## Public Rights-of-Way

### (Curb Ramps)

| Intersection ID: 10026412 | Main Street: FARM_POND_LN | Cross Street: N/A | Location: NE |

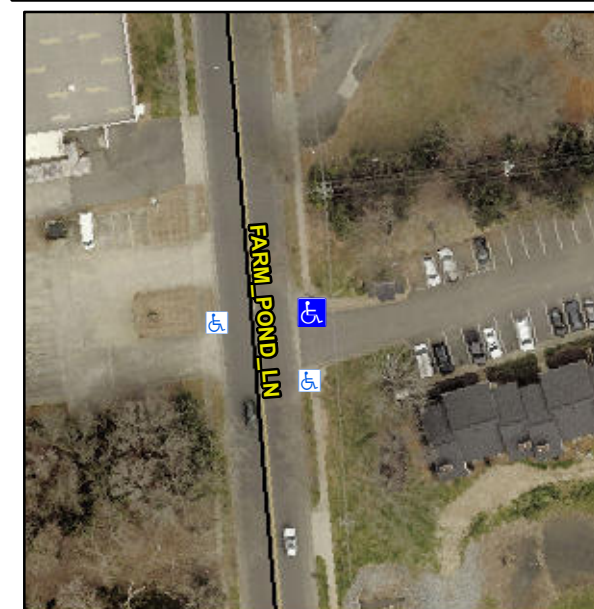
| ADA ID: F3B1352006F0 | Ramp Type: PerpDiag | Initial Pass/Fail: Fail | Overall Compliance: No |

**R304.2.2, R304.5.3**

| Compliance | Description | Data | Compliance | Description | Data |
|---|---|---|---|---|---|
| N/A | Ramp Length (in) | 58.0 | No | Ramp Slope (%) | 13.1 |
| Yes | Ramp Width (in) | 48.0 | No | Ramp XSlope (%) | 4.0 |

**Remove & Replace Curb Ramp With Two New Directional Ramps or Equivalent.**

Total Cost: \$ 3200.00
