Access Compliance Report

Public Rights-of-Way

(Curb Ramps)

Intersection ID: 44455	Main Street: AMES_HOLLOW_RD	Cross Street: BUCKHORN_ST	Location: SE
ADA ID: F3B50CA41477	Ramp Type: PerpDiag	Initial Pass/Fail: Fail	Overall Compliance: No
		Severity Score: 10

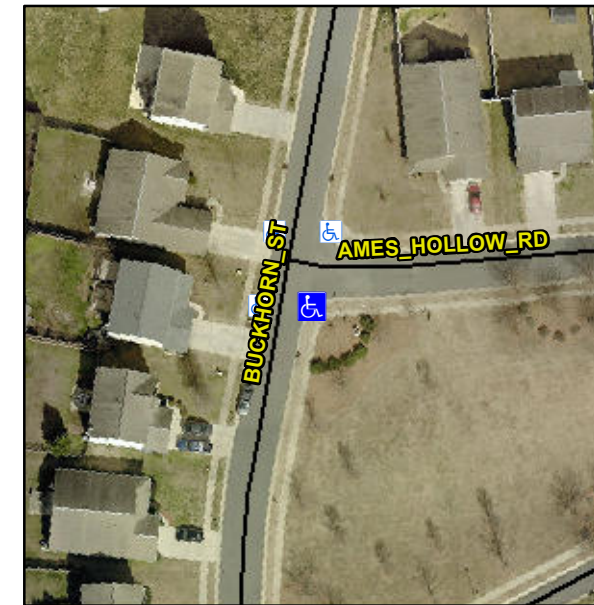
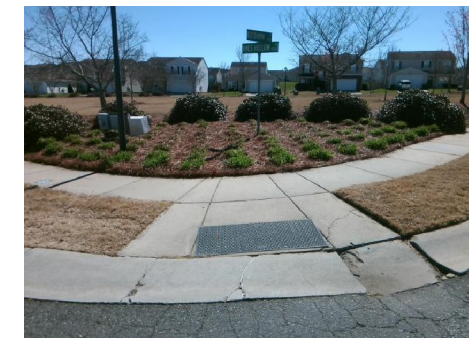
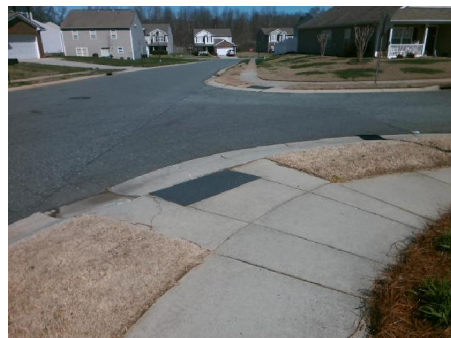
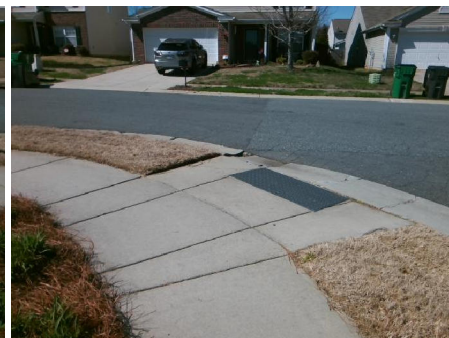
Not Found, R304.5.1, R304.5.3

Compliance	Description	Data	Compliance	Description	Data
N/A	Ramp Length (in)	53.0	Yes	Ramp Slope (%)	5.0
No	Ramp Width (in)	38.5	No	Ramp XSlope (%)	4.8
N/A	Flare Type LT	N/A	N/A	Flare Type RT	N/A
N/A	Flare Slope LT (%)	N/A	N/A	Flare Slope RT (%)	N/A
N/A	Flare Traversable LT?	N/A	N/A	Flare Traversable RT?	N/A
N/A	Landing Length (in)	N/A	N/A	DWS Provided?	N/A
N/A	Landing Width (in)	N/A	N/A	DWS Contrast?	N/A
N/A	Landing Slope (%)	N/A	N/A	DWS Length (in)	N/A
N/A	Landing X Slope (%)	N/A	N/A	DWS Full Width?	N/A
N/A	Landing Curb? (Y/N)	N/A	N/A	DWS Offset (in)	N/A
N/A	Shared Landing?	N/A			
N/A	Gutter Ponding?	N/A	N/A	Gutter Slope (%)	N/A
N/A	Gutter Lip Ht (in)	N/A	N/A	Gutter X Slope (%)	N/A
N/A	Painted X Walk1?	No	N/A	Painted X Walk2?	No
	X Walk 1 Direction	To N		X Walk 2 Direction	To W
N/A	X Walk 1 Width (in)	N/A	N/A	X Walk 2 Width (in)	N/A
	X Walk 1 Slope (%)	4.2		X Walk 2 Slope (%)	3.0
	X Walk 1 X Slope (%)	1.7		X Walk 2 X Slope (%)	1.9

N/A	Ramp inside XWalk1?	N/A	N/A	Ramp inside XWalk2?	N/A
	Road Slope (%)	2.6	N/A	Clear Space?	N/A
	Road X Slope (%)	1.1	N/A	Clear Space to XWalk (in)	N/A
N/A	Any Obstructions?	N/A	N/A	Storm Grate/Utility Hazard?	N/A
	Obstruction Type			Storm Grate/Utility Type	
		N/A			N/A
			Yes	Surface Condition? (G/P)	Good

Remove & Replace Curb Ramp With Two New Directional Ramps or Equivalent.
