# Access Compliance Report

## Public Rights-of-Way

### (Curb Ramps)

Intersection ID: 16628	Main Street: CEDAR_TREE_LN	Cross Street: WALNUT_WOOD_DR	Location: SE
ADA ID: F3CD2E956948	Ramp Type: Directional1	Initial Pass/Fail: Fail	Overall Compliance: No
Severity Score: 21.25			
Codes/Mitigation Info/Possible Solution		Field Measurements/Component Compliance

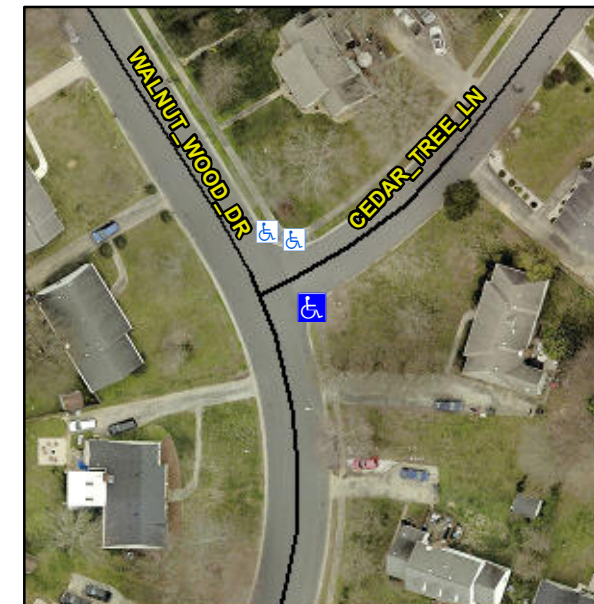
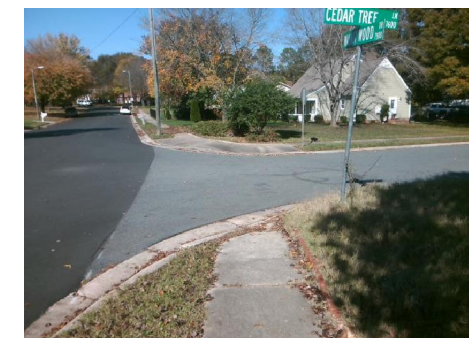
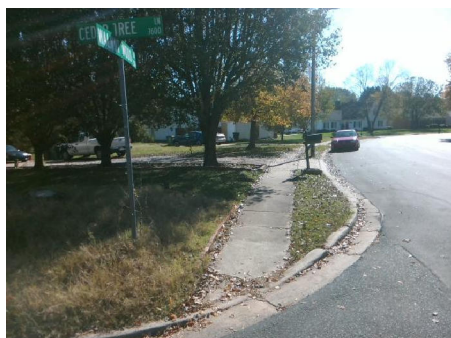
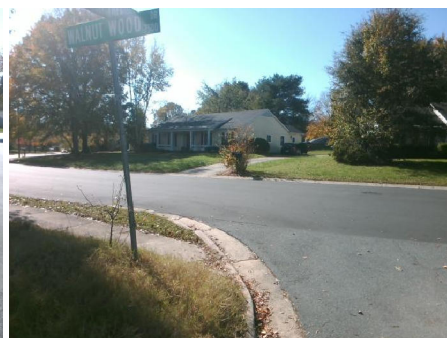
**ASP LIP 0.5"**

**R304.5.1, R304.5.3**

Compliance	Description	Data	Compliance	Description	Data
N/A	Ramp Length (in)	65.0	N/A	Grade Break?	N/A
No	Ramp Width (in)	46.0	N/A	Grade Break Slope (%)	0.0
Yes	Ramp Slope (%)	4.6	N/A	Grade Break XSlope (%)	0.0
No	Ramp XSlope (%)	5.1			
N/A	Flare Type LT	N/A	N/A	Flare Type RT	N/A
N/A	Flare Slope LT (%)	N/A	N/A	Flare Slope RT (%)	0.0
N/A	Flare Traversable LT?	N/A	N/A	Flare Traversable RT?	N/A
N/A	Landing Length (in)	0.0	N/A	DWS Provided?	N/A
N/A	Landing Width (in)	0.0	N/A	DWS Contrast?	N/A
N/A	Landing Slope (%)	0.0	N/A	DWS Length (in)	N/A
N/A	Landing X Slope (%)	0.0	N/A	DWS Full Width?	N/A
N/A	Landing Curb? (Y/N)	N/A	N/A	DWS Offset LT (in)	N/A
N/A	Shared Landing?	N/A	N/A	DWS Offset RT (in)	N/A
N/A	Gutter Ponding?	0.0	N/A	Gutter Slope (%)	N/A
N/A	Gutter Lip Ht (in)	1.0	N/A	Gutter X Slope (%)	N/A
N/A	Painted X Walk1?	No		Road Slope (%)	2.0
	X Walk 1 Direction	To N		Road X Slope (%)	6.3
	X Walk 1 Width (in)	N/A		Clear Space?	N/A

X Walk 1 Slope (%)	2.0	N/A	Clear Space to XWalk (in)	N/A
	X Walk 1 X Slope (%)	6.3	N/A	Storm Grate/Utility Hazard?	N/A
N/A	Ramp inside XWalk1?	N/A		Storm Grate/Utility Type	
N/A	Any Obstructions?	N/A			N/A
	Obstruction Type		Yes	Surface Condition? (G/P)	Good
			N/A	Curb Slope (%)	0.5

**Remove & Replace Entire Ramp.**

Total Cost: \$ 1600.00
