Access Compliance Report

Public Rights-of-Way

(Curb Ramps)

Intersection ID: 14954	Main Street: BROMLEY_RD	Cross Street: E_MOREHEAD_ST	Location: NE
ADA ID: F3CE5FF7480C	Ramp Type: BlendTrans1	Initial Pass/Fail: Fail	Overall Compliance: No
		Severity Score: 12.5

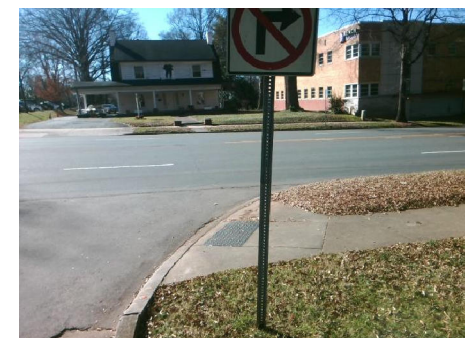
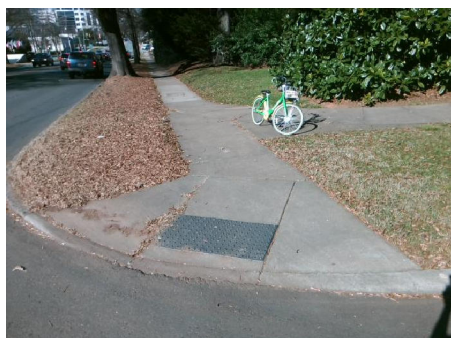
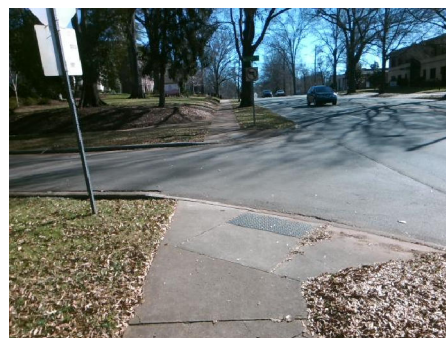
Not Found, R304.5.3

Compliance	Description	Data	Compliance	Description	Data
N/A	Ramp Length (in)	73.0	Yes	BlendTrans Slope (%)	4.8
Yes	Ramp Width (in)	48.0	No	BlendTrans XSlope (%)	6.5
N/A	Flare Type LT	N/A	N/A	Flare Type RT	N/A
N/A	Flare Slope LT (%)	N/A	N/A	Flare Slope RT (%)	N/A
N/A	Flare Traversable LT?	N/A	N/A	Flare Traversable RT?	N/A
N/A	Landing Length (in)	N/A	N/A	DWS Provided?	N/A
N/A	Landing Width (in)	N/A	N/A	DWS Contrast?	N/A
N/A	Landing Slope (%)	N/A	N/A	DWS Length (in)	N/A
N/A	Landing X Slope (%)	N/A	N/A	DWS Full Width?	N/A
N/A	Landing Curb? (Y/N)	N/A	N/A	DWS Offset (in)	N/A
N/A	Shared Landing?	N/A			
N/A	Gutter Ponding?	N/A	N/A	Gutter Slope (%)	N/A
N/A	Gutter Lip Ht (in)	N/A	N/A	Gutter X Slope (%)	N/A
N/A	Painted X Walk1?	No	N/A	Painted X Walk2?	No
	X Walk 1 Direction	To SE		X Walk 2 Direction	To SW
	X Walk 1 Width (in)	N/A		X Walk 2 Width (in)	N/A
	X Walk 1 Slope (%)	1.2		X Walk 2 Slope (%)	8.9
	X Walk 1 X Slope (%)	8.6		X Walk 2 X Slope (%)	0.0

N/A	Ramp inside XWalk1?	N/A	N/A	Ramp inside XWalk2?	N/A
	Road Slope (%)	5.0		Clear Space?	N/A
	Road X Slope (%)	8.2	N/A	Clear Space to XWalk (in)	N/A
N/A	Any Obstructions?	N/A	N/A	Storm Grate/Utility Hazard?	N/A
	Obstruction Type			Storm Grate/Utility Type	
		N/A			N/A
			Yes	Surface Condition? (G/P)	Good
			No	Curb Slope (%)	8.8

Remove & Replace Curb Ramp With Two New Directional Ramps or Equivalent.
