Access Compliance Report

Public Rights-of-Way

(Curb Ramps)

Intersection ID: 44850	Main Street: STEELE_CREEK_RD	Cross Street: SHOPTON_RD_WEST	Location: NE
ADA ID: F3D3C91CE72E	Ramp Type: BlendTrans1	Initial Pass/Fail: Fail	Overall Compliance: No
Severity Score: 8.75			
Codes/Mitigation Info/Possible Solution		Field Measurements/Component Compliance

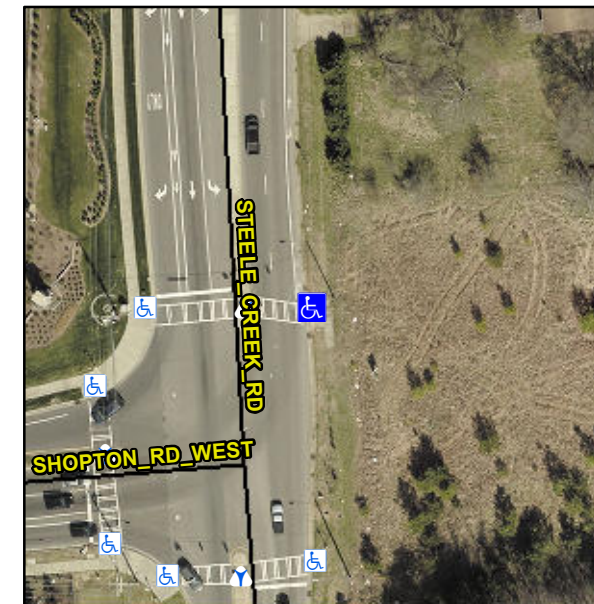
Not Found, R304.5.1

Compliance	Description	Data	Compliance	Description	Data
N/A	Ramp Length (in)	72.0	Yes	BlendTrans Slope (%)	4.0
No	Ramp Width (in)	46.5	Yes	BlendTrans XSlope (%)	1.9
N/A	Flare Type LT	N/A	N/A	Flare Type RT	N/A
N/A	Flare Slope LT (%)	N/A	N/A	Flare Slope RT (%)	N/A
N/A	Flare Traversable LT?	N/A	N/A	Flare Traversable RT?	N/A
N/A	Landing Length (in)	N/A	N/A	DWS Provided?	N/A
N/A	Landing Width (in)	N/A	N/A	DWS Contrast?	N/A
N/A	Landing Slope (%)	N/A	N/A	DWS Length (in)	N/A
N/A	Landing X Slope (%)	N/A	N/A	DWS Full Width?	N/A
N/A	Landing Curb? (Y/N)	N/A	N/A	DWS Offset (in)	N/A
N/A	Shared Landing?	N/A			
N/A	Gutter Ponding?	N/A	N/A	Gutter Slope (%)	N/A
N/A	Gutter Lip Ht (in)	N/A	N/A	Gutter X Slope (%)	N/A
N/A	Painted X Walk1?	Yes	N/A	Painted X Walk2?	N/A
	X Walk 1 Direction	To W		X Walk 2 Direction	N/A
	X Walk 1 Width (in)	111.0		X Walk 2 Width (in)	N/A
	X Walk 1 Slope (%)	2.1		X Walk 2 Slope (%)	N/A
	X Walk 1 X Slope (%)	0.9		X Walk 2 X Slope (%)	N/A

N/A	Ramp inside XWalk1?	Yes	N/A	Ramp inside XWalk2?	N/A
	Road Slope (%)	0.9		Clear Space?	N/A
	Road X Slope (%)	2.1	N/A	Clear Space to XWalk (in)	N/A
N/A	Any Obstructions?	N/A	N/A	Storm Grate/Utility Hazard?	N/A
	Obstruction Type			Storm Grate/Utility Type	
		N/A			N/A
			Yes	Surface Condition? (G/P)	Good
			No	Curb Slope (%)	9.1

Remove & Replace Curb Ramp With Two New Directional Ramps or Equivalent.
