# Access Compliance Report

## Public Rights-of-Way

### (Curb Ramps)

Intersection ID: 12243	Main Street: GAINESBOROUGH_RD	Cross Street: SHAMROCK_DR	Location: S
ADA ID: F3D59032841A	Ramp Type: PerpDiag	Initial Pass/Fail: Fail	Overall Compliance: No
		Severity Score: 22.5

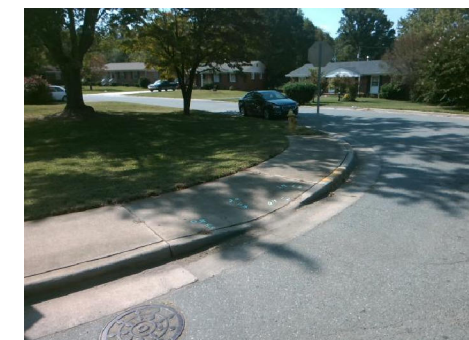
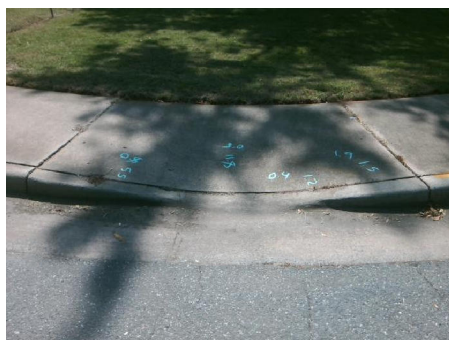
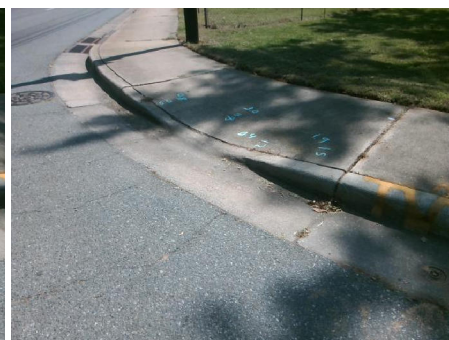
**Not Found, R304.5.1, R304.2.2, R304.5.3**

Compliance	Description	Data	Compliance	Description	Data
N/A	Ramp Length (in)	59.5	No	Ramp Slope (%)	11.8
No	Ramp Width (in)	36.0	No	Ramp XSlope (%)	3.0
N/A	Flare Type LT	N/A	N/A	Flare Type RT	N/A
N/A	Flare Slope LT (%)	N/A	N/A	Flare Slope RT (%)	N/A
N/A	Flare Traversable LT?	N/A	N/A	Flare Traversable RT?	N/A
N/A	Landing Length (in)	N/A	N/A	DWS Provided?	N/A
N/A	Landing Width (in)	N/A	N/A	DWS Contrast?	N/A
N/A	Landing Slope (%)	N/A	N/A	DWS Length (in)	N/A
N/A	Landing X Slope (%)	N/A	N/A	DWS Full Width?	N/A
N/A	Landing Curb? (Y/N)	N/A	N/A	DWS Offset (in)	N/A
N/A	Shared Landing?	N/A			
N/A	Gutter Ponding?	N/A	N/A	Gutter Slope (%)	N/A
N/A	Gutter Lip Ht (in)	N/A	N/A	Gutter X Slope (%)	N/A
N/A	Painted X Walk1?	No	N/A	Painted X Walk2?	No
	X Walk 1 Direction	To NE		X Walk 2 Direction	To NW
N/A	X Walk 1 Width (in)	N/A	N/A	X Walk 2 Width (in)	N/A
	X Walk 1 Slope (%)	5.5		X Walk 2 Slope (%)	1.5
	X Walk 1 X Slope (%)	0.8		X Walk 2 X Slope (%)	1.9

N/A	Ramp inside XWalk1?	N/A	N/A	Ramp inside XWalk2?	N/A
	Road Slope (%)	0.4	N/A	Clear Space?	N/A
	Road X Slope (%)	1.2	N/A	Clear Space to XWalk (in)	N/A
N/A	Any Obstructions?	N/A	N/A	Storm Grate/Utility Hazard?	N/A
	Obstruction Type			Storm Grate/Utility Type	
		N/A			N/A
			Yes	Surface Condition? (G/P)	Good

**Remove & Replace Curb Ramp With Two New Directional Ramps or Equivalent.**

Total Cost: \$ 3200.00
