## Access Compliance Report Public Rights-of-Way (Curb Ramps)

Intersection ID: N/AMain Street: YORK\_CENTERCross Street: N/ALocation: NWADA ID: F3DD397243DDRamp Type: PerpDiagInitial Pass/Fail: FailOverall Compliance: NoSeverity Score: 22.5

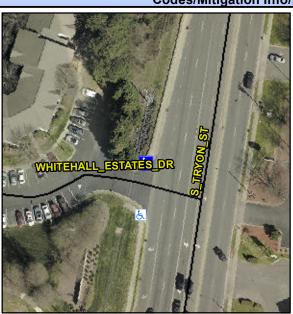
Compliance Description		Data	Comp	liance	Description	Data
N/A	Ramp Length (in)	51.0	No	Ram	Slope (%)	8.4
No	Ramp Width (in)	47.0	No	Ramp XSlope (%)		2.2
N/A	Flare Type LT	N/A	N/A	Flare	Type RT	N/A
N/A	Flare Slope LT (%)	N/A	N/A	Flare	Slope RT (%)	N/A
N/A	Flare Traversable LT?	N/A	N/A	Flare	Traversable RT?	N/A
N/A	Landing Length (in)	N/A	N/A	DWS	Provided?	N/A
N/A	Landing Width (in)	N/A	N/A	DWS	Contrast?	N/A
N/A	Landing Slope (%)	N/A	N/A	DWS	Length (in)	N/A
N/A	Landing X Slope (%)	N/A	N/A	DWS	Full Width?	N/A
N/A	Landing Curb? (Y/N)	N/A	N/A	DWS	Offset (in)	N/A
N/A	Shared Landing?	N/A				
N/A	Gutter Ponding?	N/A	N/A	Gutte	er Slope (%)	N/A
N/A	Gutter Lip Ht (in)	N/A	N/A	Gutte	er X Slope (%)	N/A
N/A	Painted X Walk1?	No	N/A	Paint	ed X Walk2?	No
	X Walk 1 Direction	To S		X Wa	lk 2 Direction	То Е
N/A	X Walk 1 Width (in)	N/A	N/A	X Wa	lk 2 Width (in)	N/A
	X Walk 1 Slope (%)	0.8		X Wa	lk 2 Slope (%)	2.0
	X Walk 1 X Slope (%)	4.4		X Wa	lk 2 X Slope (%)	1.3

N/A	Ramp inside XWalk1?	N/A	N/A	Ram	o inside XWalk2?	N/A
	Road Slope (%)	0.2	N/A	Clear	Space?	N/A
	Road X Slope (%)	2.5	N/A	Clear	Space to XWalk (in)	N/A
N/A	Any Obstructions?	N/A	N/A	Storn	n Grate/Utility Hazard?	N/A
	Obstruction Type		l	Storn	n Grate/Utility Type	
		N/A				N/A
			Yes	Surfa	ce Condition? (G/P)	Good

Remove & Replace Curb Ramp With Two New Directional Ramps or Equivalent.
