# Access Compliance Report

## Public Rights-of-Way

### (Curb Ramps)

| Intersection ID: 52450 | Main Street: TRANQUIL_OAK_PL | Cross Street: MOSS_LN | Location: NE |

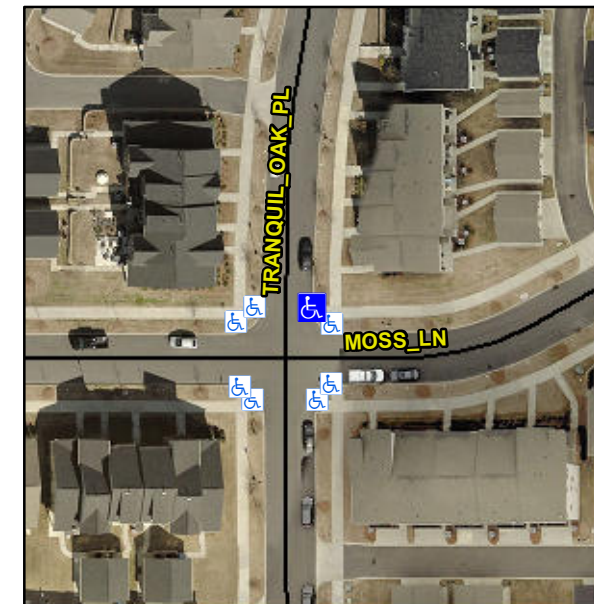
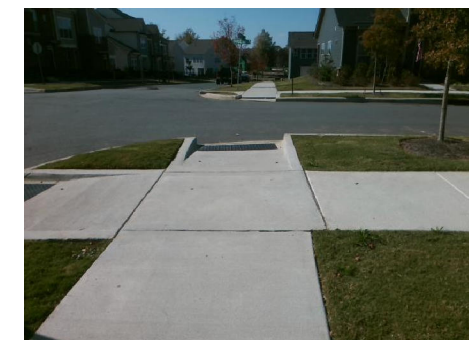
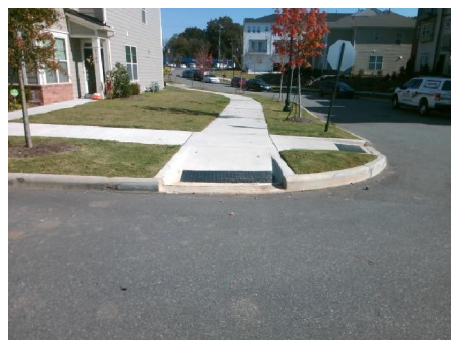
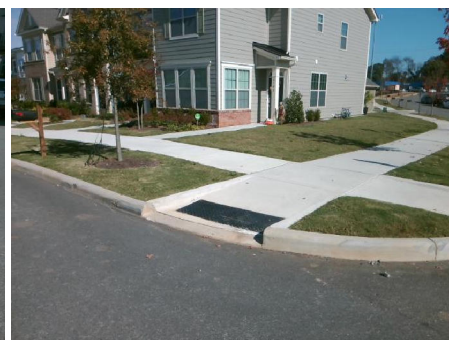
| Severity Score: 17.5 | | | |

**R304.5.3, R305.1.4, R302.7.2**

| Compliance | Description | Data | Compliance | Description | Data |
|---|---|---|---|---|---|
| Yes | Ramp Width (in) | 67.0 | No | Grade Break Slope (%) | 5.4 |
| Yes | Ramp Slope (%) | 2.9 | No | Grade Break XSlope (%) | 2.6 |
| Yes | Landing X Slope (%) | 0.6 | No | DWS Full Width? | No |
| No | Gutter Lip Ht (in) | 1.0 | No | Gutter X Slope (%) | 2.8 |

**Remove & Replace Entire Ramp.  
Remove & Replace Gutter.**
