# Access Compliance Report

## Public Rights-of-Way

| Intersection ID: 49920 | Main Street: AUSTIN_DEKOTA_DR | Cross Street: WANAMASSA_DR | Location: S |
| ADA ID: F3E1D9784B56 | Ramp Type: BlendTrans1 | Initial Pass/Fail: Fail | Overall Compliance: No |

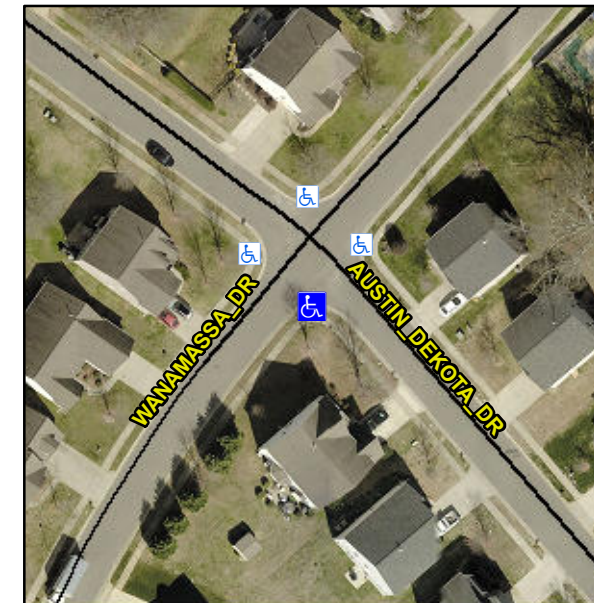
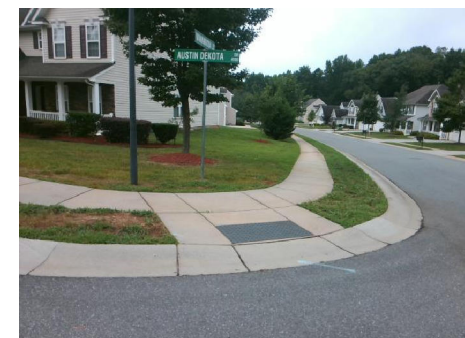
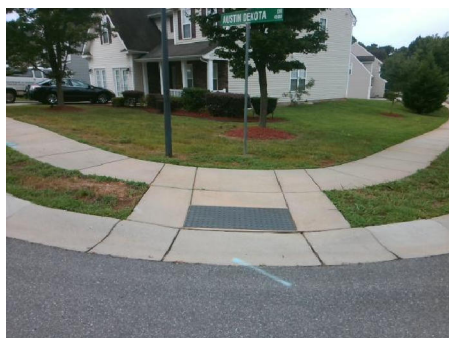
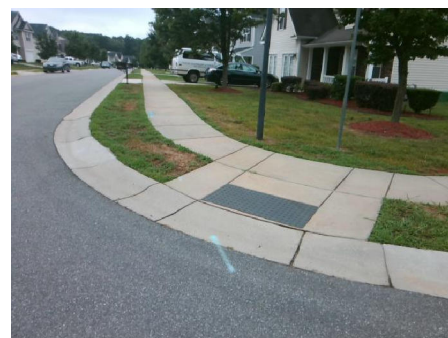
| | | Severity Score: 1.25 | |

**Not Found, R304.5.3**

| Compliance | Description | Data | Compliance | Description | Data |
|---|---|---|---|---|---|
| Yes | Ramp Width (in) | 48.0 | No | BlendTrans XSlope (%) | 4.7 |
| | | | No | Curb Slope (%) | 11.6 |

**Remove & Replace Curb Ramp With Two New Directional Ramps or Equivalent.**

Total Cost: \$ 3200.00
