# Access Compliance Report

## Public Rights-of-Way

### (Curb Ramps)

Intersection ID: 53090	Main Street: BRADFORD_HALL_PL	Cross Street: DEERFIELD_MANOR_DR	Location: S
ADA ID: F3E2A2B6E001	Ramp Type: Perp	Initial Pass/Fail: Pass	Overall Compliance: No
Codes/Mitigation Info/Possible Solution		Field Measurements/Component Compliance	
Severity Score: 20

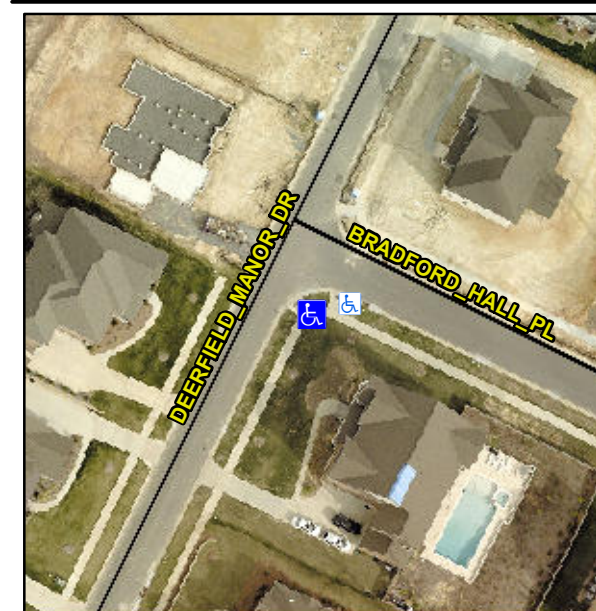
**Not Found, R305.2, R302.7.2,  
R304.5.4**

Compliance	Description	Data	Compliance	Description	Data
N/A	Ramp Length (in)	95.0	Yes	Ramp Slope (%)	5.3
Yes	Ramp Width (in)	48.0	Yes	Ramp XSlope (%)	0.6
N/A	Flare Type LT	Sloped	N/A	Flare Type RT	N/A
N/A	Flare Slope LT (%)	6.0	Yes	Flare Slope RT (%)	5.4
N/A	Flare Traversable LT?	Yes	N/A	Flare Traversable RT?	Yes
Yes	Landing Length (in)	60.0	Yes	DWS Provided?	Yes
Yes	Landing Width (in)	61.0	Yes	DWS Contrast?	Yes
Yes	Landing Slope (%)	0.1	Yes	DWS Length (in)	24.0
Yes	Landing X Slope (%)	1.2	Yes	DWS Full Width?	Yes
N/A	Landing Curb? (Y/N)	No	No	DWS Offset (in)	4.5
N/A	Shared Landing?	No			
Yes	Gutter Ponding?	No	No	Gutter Slope (%)	7.0
No	Gutter Lip Ht (in)	1.5	Yes	Gutter X Slope (%)	0.2
N/A	Painted X Walk1?	No	N/A	Painted X Walk2?	N/A
	X Walk 1 Direction	To NW		X Walk 2 Direction	N/A
N/A	X Walk 1 Width (in)	N/A	N/A	X Walk 2 Width (in)	N/A
	X Walk 1 Slope (%)	1.9		X Walk 2 Slope (%)	N/A
	X Walk 1 X Slope (%)	0.4		X Walk 2 X Slope (%)	N/A

N/A	Ramp inside XWalk1?	N/A	N/A	Ramp inside XWalk2?	N/A
	Road Slope (%)	N/A	N/A	Clear Space?	Yes
	Road X Slope (%)	N/A	N/A	Clear Space to XWalk (in)	N/A
Yes	Any Obstructions?	No	Yes	Storm Grate/Utility Hazard?	No
	Obstruction Type			Storm Grate/Utility Type	
		N/A			N/A
			Yes	Surface Condition? (G/P)	Good

Possible Solutions:

**Remove & Replace Entire Ramp.  
Remove & Replace Gutter.**
