Access Compliance Report

Public Rights-of-Way

(Curb Ramps)

| Intersection ID: 23951 | Main Street: S_TRYON_ST | Cross Street: CHOATE_CR | Location: SW |

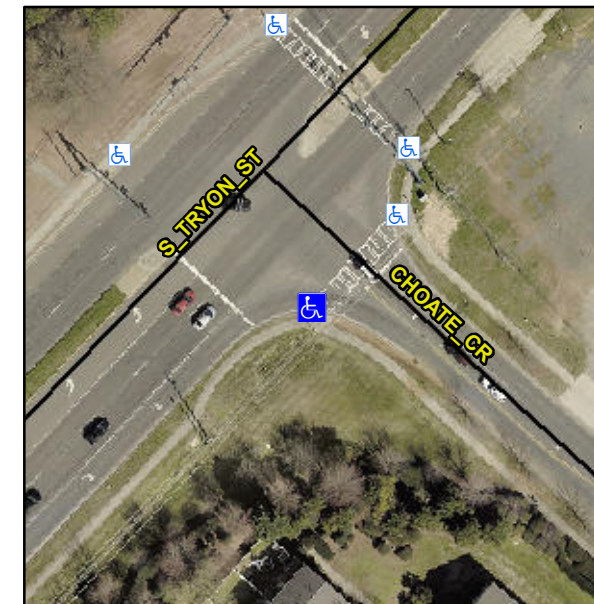
| ADA ID: F3EB94FA19CE | Ramp Type: PerpDiag | Initial Pass/Fail: Fail | Overall Compliance: No |

Not Found, R304.5.1

| Compliance | Description | Data | Compliance | Description | Data |
|---|---|---|---|---|---|
| N/A | Ramp Length (in) | 108.0 | Yes | Ramp Slope (%) | 6.7 |
| No | Ramp Width (in) | 47.0 | Yes | Ramp XSlope (%) | 3.4 |

Remove & Replace Curb Ramp With Two New Directional Ramps or Equivalent.

Total Cost: \$ 3200.00
