Access Compliance Report Public Rights-of-Way (Curb Ramps)

Intersection ID: 30294	Main Street: ELSPEDBY IN	Croce Str		קח		Location:	w
	Main Street: ELSBERRY_LN		Cross Street: RAVANNA_DR				
ADA ID: F3EF21AB04AD	4AD Ramp Type: PerpDiag		Initial Pass/Fail: Fail Overall Compliance: No			Severity Score:	47.5
Codes/Mitigation Info/Possible Solution			Field Measurements/Component Compliance				
	Possible Solutions:	<u>C</u>	Compliance Description		Data Compliance Description		Data
SPE /	Remove & Replace Curb Ramp	With N/	A Ramp Lengt	th (in) 48.5	Yes	Ramp Slope (%)	5.0
	Two New Directional Ramps or		Ramp Width	n (in) 31.0	No	Ramp XSlope (%)	6.3
	Equivalent.	N/	A Flare Type L	_T N/A	N/A	Flare Type RT	N/A
	i IL	N	A Flare Slope	LT (%) N/A	N/A	Flare Slope RT (%)	N/A
NOT		N	A Flare Traver	sable LT? N/A	N/A	Flare Traversable RT?	N/A
the B	15 10.	N	A Landing Len	ngth (in) N/A	N/A	DWS Provided?	N/A
E S	Surveyor Notes:	N	A Landing Wid	th (in) N/A	N/A	DWS Contrast?	N/A
ES /	N/A	N	A Landing Slo	pe (%) N/A	N/A	DWS Length (in)	N/A

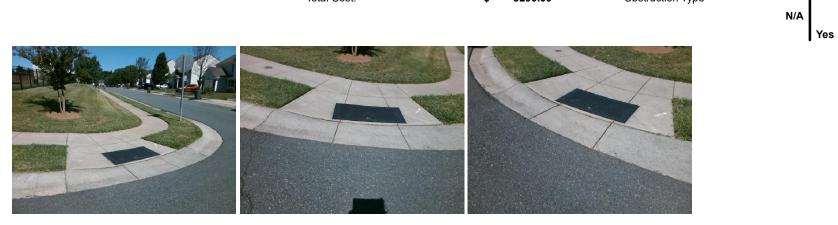
N	A Landing X S	lope (%) N/A	N/A	DWS Full Width?	N/A
		N	A Landing Cur	b? (Y/N) N/A	N/A	DWS Offset (in)	N/A
		N	A Shared Land	ding? N/A			
	PROW/ADA:	N	A Gutter Pond	ling? N/A	N/A	Gutter Slope (%)	N/A
R I I MARKEN / 1000 A	Not Found, R304.5.1, R304.5.3	N/	A Gutter Lip H	t (in) N/A	N/A	Gutter X Slope (%)	N/A
	,, ,, ,, ,, ,, ,, ,, ,, ,, ,, ,, ,, ,, ,,	N	A Painted X W	/alk1? No	N/A	Painted X Walk2?	No
			X Walk 1 Dir	rection To S		X Walk 2 Direction	To N
	and the second sec	N	A X Walk 1 Wi	idth (in) N/A	N/A	X Walk 2 Width (in)	N/A
Street 1 Name RAV	ANNA DR		X Walk 1 Slo	ope (%) 0.8		X Walk 2 Slope (%)	6.6
Stop Condition-Street 2	None		X Walk 1 X S	Slope (%) 5.6		X Walk 2 X Slope (%)	0.1
Street 2 Name ELSB	BERRY LN	N	A Ramp inside	XWalk1? N/A	N/A	Ramp inside XWalk2?	N/A
Stop Condition-Street 1	StopSign		Road Slope	(%) 6.3	N/A	Clear Space?	N/A
			Road X Slop	be (%) 2.7	N/A	Clear Space to XWalk (in)	N/A
		N	A Any Obstruc	tions? N/A	N/A	Storm Grate/Utility Hazard?	N/A

es Surface Condition? (G/P)

Good

Total Cost: \$	3200.00	Obstruction	Туре		Storm Grate/Utility Type	
				N/A			N/A
