Access Compliance Report

Public Rights-of-Way

(Curb Ramps)

Intersection ID: 5153	Main Street: CHIDLEY_DR	Cross Street: EDMONTON_PL	Location:	N
ADA ID: F3F08D6D8B12	Ramp Type: Perp	Initial Pass/Fail: Fail	Overall Compliance: No	Severity Score: 50
Codes/Mitigation Info/Possible Solution		Field Measurements/Component Compliance

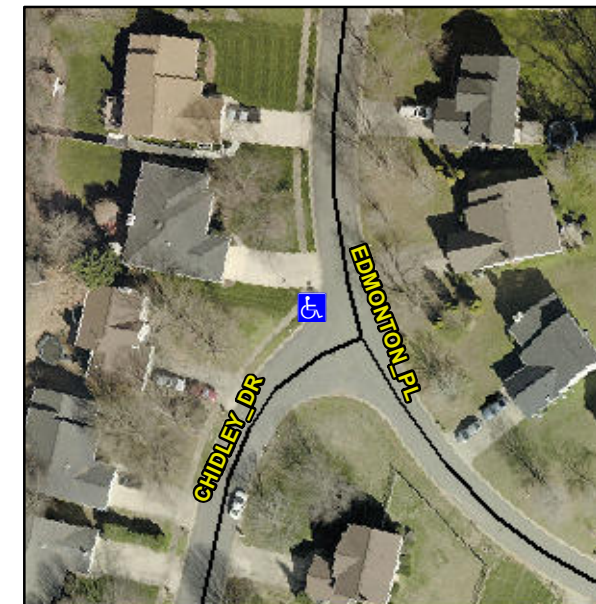
Not Found, R304.2.2, R304.5.3

Compliance	Description	Data	Compliance	Description	Data
N/A	Ramp Length (in)	48.0	No	Ramp Slope (%)	13.6
Yes	Ramp Width (in)	48.0	No	Ramp XSlope (%)	7.1
N/A	Flare Type LT	N/A	N/A	Flare Type RT	N/A
N/A	Flare Slope LT (%)	N/A	N/A	Flare Slope RT (%)	N/A
N/A	Flare Traversable LT?	N/A	N/A	Flare Traversable RT?	N/A
N/A	Landing Length (in)	N/A	N/A	DWS Provided?	N/A
N/A	Landing Width (in)	N/A	N/A	DWS Contrast?	N/A
N/A	Landing Slope (%)	N/A	N/A	DWS Length (in)	N/A
N/A	Landing X Slope (%)	N/A	N/A	DWS Full Width?	N/A
N/A	Landing Curb? (Y/N)	N/A	N/A	DWS Offset (in)	N/A
N/A	Shared Landing?	N/A			
N/A	Gutter Ponding?	N/A	N/A	Gutter Slope (%)	N/A
N/A	Gutter Lip Ht (in)	N/A	N/A	Gutter X Slope (%)	N/A
N/A	Painted X Walk1?	No	N/A	Painted X Walk2?	N/A
	X Walk 1 Direction	To SE		X Walk 2 Direction	N/A
N/A	X Walk 1 Width (in)	N/A	N/A	X Walk 2 Width (in)	N/A
	X Walk 1 Slope (%)	5.2		X Walk 2 Slope (%)	N/A
	X Walk 1 X Slope (%)	4.9		X Walk 2 X Slope (%)	N/A

N/A	Ramp inside XWalk1?	N/A	N/A	Ramp inside XWalk2?	N/A
	Road Slope (%)	N/A	N/A	Clear Space?	N/A
	Road X Slope (%)	N/A	N/A	Clear Space to XWalk (in)	N/A
N/A	Any Obstructions?	N/A	N/A	Storm Grate/Utility Hazard?	N/A
	Obstruction Type			Storm Grate/Utility Type	
		N/A			N/A
			Yes	Surface Condition? (G/P)	Good

Possible Solutions:

Remove & Replace Entire Ramp.
