Access Compliance Report

Public Rights-of-Way

(Curb Ramps)

Intersection ID: 48582	Main Street: WATERLILY_LN	Cross Street: SWEET_FLAG_CT	Location: NE
ADA ID: F3F5C272EDAB	Ramp Type: PerpDiag	Initial Pass/Fail: Fail	Overall Compliance: No
Severity Score: 22.5			
Codes/Mitigation Info/Possible Solution		Field Measurements/Component Compliance

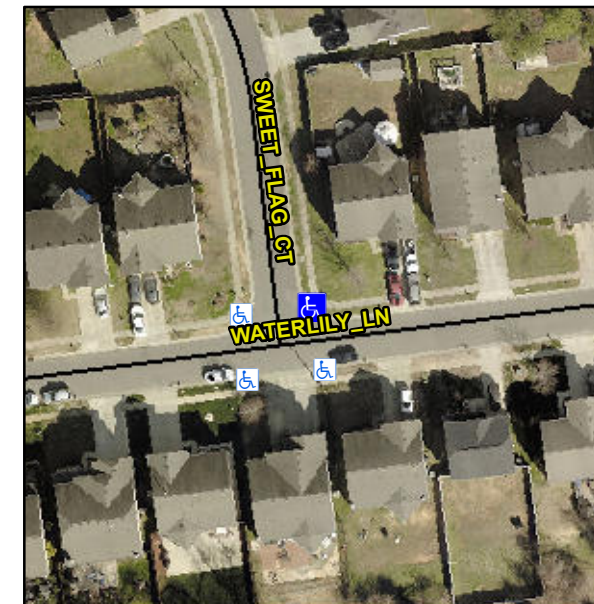
Not Found, R304.5.1, R304.2.2, R304.5.3

Compliance	Description	Data	Compliance	Description	Data
N/A	Ramp Length (in)	48.0	No	Ramp Slope (%)	10.5
No	Ramp Width (in)	47.0	No	Ramp XSlope (%)	3.5
N/A	Flare Type LT	N/A	N/A	Flare Type RT	N/A
N/A	Flare Slope LT (%)	N/A	N/A	Flare Slope RT (%)	N/A
N/A	Flare Traversable LT?	N/A	N/A	Flare Traversable RT?	N/A
N/A	Landing Length (in)	N/A	N/A	DWS Provided?	N/A
N/A	Landing Width (in)	N/A	N/A	DWS Contrast?	N/A
N/A	Landing Slope (%)	N/A	N/A	DWS Length (in)	N/A
N/A	Landing X Slope (%)	N/A	N/A	DWS Full Width?	N/A
N/A	Landing Curb? (Y/N)	N/A	N/A	DWS Offset (in)	N/A
N/A	Shared Landing?	N/A			
N/A	Gutter Ponding?	N/A	N/A	Gutter Slope (%)	N/A
N/A	Gutter Lip Ht (in)	0.5	N/A	Gutter X Slope (%)	N/A
N/A	Painted X Walk1?	No	N/A	Painted X Walk2?	No
	X Walk 1 Direction	To W		X Walk 2 Direction	To S
N/A	X Walk 1 Width (in)	N/A	N/A	X Walk 2 Width (in)	N/A
	X Walk 1 Slope (%)	0.3		X Walk 2 Slope (%)	3.4
	X Walk 1 X Slope (%)	2.3		X Walk 2 X Slope (%)	2.2

N/A	Ramp inside XWalk1?	N/A	N/A	Ramp inside XWalk2?	N/A
	Road Slope (%)	2.3	N/A	Clear Space?	N/A
	Road X Slope (%)	0.4	N/A	Clear Space to XWalk (in)	N/A
N/A	Any Obstructions?	N/A	N/A	Storm Grate/Utility Hazard?	N/A
	Obstruction Type			Storm Grate/Utility Type	
		N/A			N/A
			Yes	Surface Condition? (G/P)	Good

Possible Solutions:

Remove & Replace Curb Ramp With Two New Directional Ramps or Equivalent.
