Access Compliance Report

Public Rights-of-Way

(Curb Ramps)

Intersection ID: 12887	Main Street: CRAIGWOOD_DR	Cross Street: HICKORY_GROVE_RD	Location: NE
ADA ID: F40047E0E756	Ramp Type: PerpDiag	Initial Pass/Fail: Fail	Overall Compliance: No
			Severity Score: 21.25

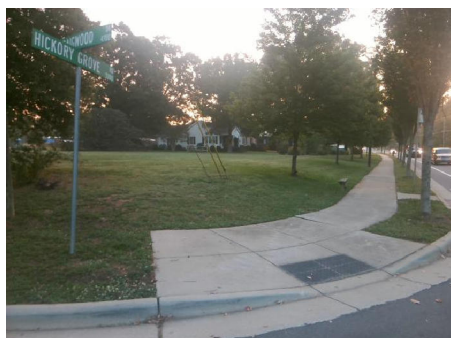
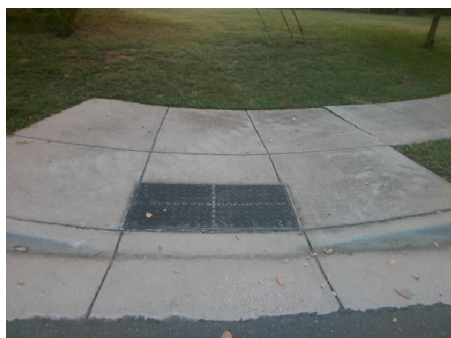
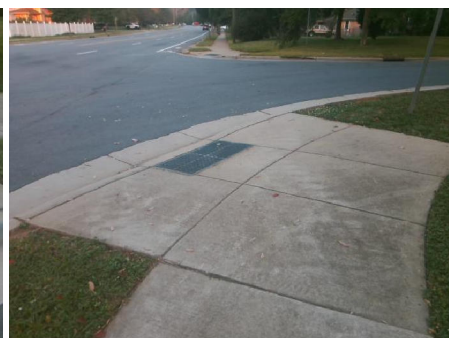
Possible Solutions:		Compliance	Description	Data	Compliance	Description	Data
	Remove & Replace Curb Ramp With Two New Directional Ramps or Equivalent.		N/A	Ramp Length (in)	47.0	No	Ramp Slope (%)	8.6
			No	Ramp Width (in)	44.5	Yes	Ramp XSlope (%)	2.0
			N/A	Flare Type LT	N/A	N/A	Flare Type RT	N/A
			N/A	Flare Slope LT (%)	N/A	N/A	Flare Slope RT (%)	N/A
			N/A	Flare Traversable LT?	N/A	N/A	Flare Traversable RT?	N/A
			N/A	Landing Length (in)	N/A	N/A	DWS Provided?	N/A
			N/A	Landing Width (in)	N/A	N/A	DWS Contrast?	N/A
			N/A	Landing Slope (%)	N/A	N/A	DWS Length (in)	N/A
			N/A	Landing X Slope (%)	N/A	N/A	DWS Full Width?	N/A
Street 1 Name	CRAIGWOOD DR		N/A	Landing Curb? (Y/N)	N/A	N/A	DWS Offset (in)	N/A
	Stop Condition-Street 2		N/A	Shared Landing?	N/A			
	Street 2 Name		N/A	Gutter Ponding?	N/A	N/A	Gutter Slope (%)	N/A

Stop Condition-Street 1		N/A	Gutter Lip Ht (in)	N/A	N/A	Gutter X Slope (%)	N/A
			N/A	Painted X Walk1?	No	N/A	Painted X Walk2?	No
				X Walk 1 Direction	To W		X Walk 2 Direction	To S
			N/A	X Walk 1 Width (in)	N/A	N/A	X Walk 2 Width (in)	N/A
				X Walk 1 Slope (%)	2.5		X Walk 2 Slope (%)	2.2
				X Walk 1 X Slope (%)	0.7		X Walk 2 X Slope (%)	1.9
			N/A	Ramp inside XWalk1?	N/A	N/A	Ramp inside XWalk2?	N/A
			Road Slope (%)	3.4	N/A	Clear Space?	N/A	
			Road X Slope (%)	0.1	N/A	Clear Space to XWalk (in)	N/A	
		N/A	Any Obstructions?	N/A	N/A	Storm Grate/Utility Hazard?	N/A	
			Obstruction Type			Storm Grate/Utility Type		
				N/A			N/A	
					Yes	Surface Condition? (G/P)	Good
