# Access Compliance Report

## Public Rights-of-Way

### (Curb Ramps)

Intersection ID: 15247	Main Street: E_INDEPENDENCE_BV	Cross Street: EASTWAY_DR_RA	Location: SW
ADA ID: F402303D1AFA	Ramp Type: BlendTrans1	Initial Pass/Fail: Fail	Overall Compliance: No
Severity Score: 10			
Codes/Mitigation Info/Possible Solution		Field Measurements/Component Compliance

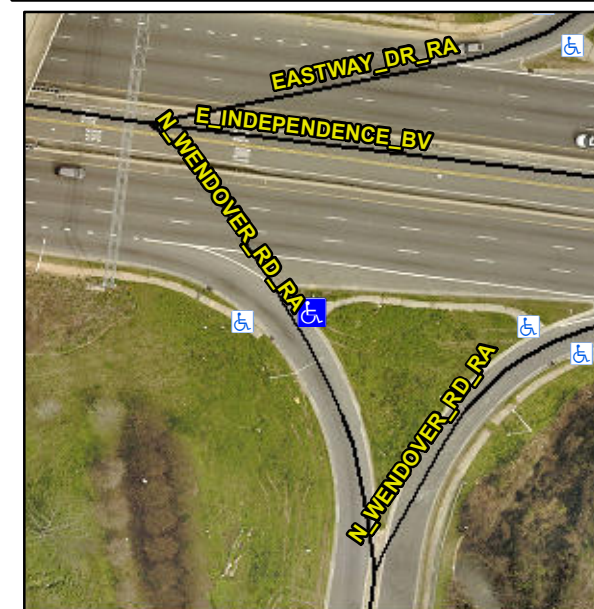
**LOCATED ON ISLAND**

**Not Found, R304.5.1, R304.5.3**

Compliance	Description	Data	Compliance	Description	Data
N/A	Ramp Length (in)	98.0	Yes	BlendTrans Slope (%)	2.9
No	Ramp Width (in)	44.0	No	BlendTrans XSlope (%)	3.3
N/A	Flare Type LT	N/A	N/A	Flare Type RT	N/A
N/A	Flare Slope LT (%)	N/A	N/A	Flare Slope RT (%)	N/A
N/A	Flare Traversable LT?	N/A	N/A	Flare Traversable RT?	N/A
N/A	Landing Length (in)	N/A	N/A	DWS Provided?	N/A
N/A	Landing Width (in)	N/A	N/A	DWS Contrast?	N/A
N/A	Landing Slope (%)	N/A	N/A	DWS Length (in)	N/A
N/A	Landing X Slope (%)	N/A	N/A	DWS Full Width?	N/A
N/A	Landing Curb? (Y/N)	N/A	N/A	DWS Offset (in)	N/A
N/A	Shared Landing?	N/A			
N/A	Gutter Ponding?	N/A	N/A	Gutter Slope (%)	N/A
N/A	Gutter Lip Ht (in)	N/A	N/A	Gutter X Slope (%)	N/A
N/A	Painted X Walk1?	No	N/A	Painted X Walk2?	N/A
	X Walk 1 Direction	To W		X Walk 2 Direction	N/A
	X Walk 1 Width (in)	N/A		X Walk 2 Width (in)	N/A
	X Walk 1 Slope (%)	7.6		X Walk 2 Slope (%)	N/A
	X Walk 1 X Slope (%)	2.6		X Walk 2 X Slope (%)	N/A

N/A	Ramp inside XWalk1?	N/A	N/A	Ramp inside XWalk2?	N/A
	Road Slope (%)	2.6		Clear Space?	N/A
	Road X Slope (%)	7.6	N/A	Clear Space to XWalk (in)	N/A
N/A	Any Obstructions?	N/A	N/A	Storm Grate/Utility Hazard?	N/A
	Obstruction Type			Storm Grate/Utility Type	
		N/A			N/A
			Yes	Surface Condition? (G/P)	Good
			No	Curb Slope (%)	16.6

**Remove & Replace Curb Ramp With Two New Directional Ramps or Equivalent.**
